CHAPTER V

STRUCTURAL DAMAGE FROM AIR BLAST

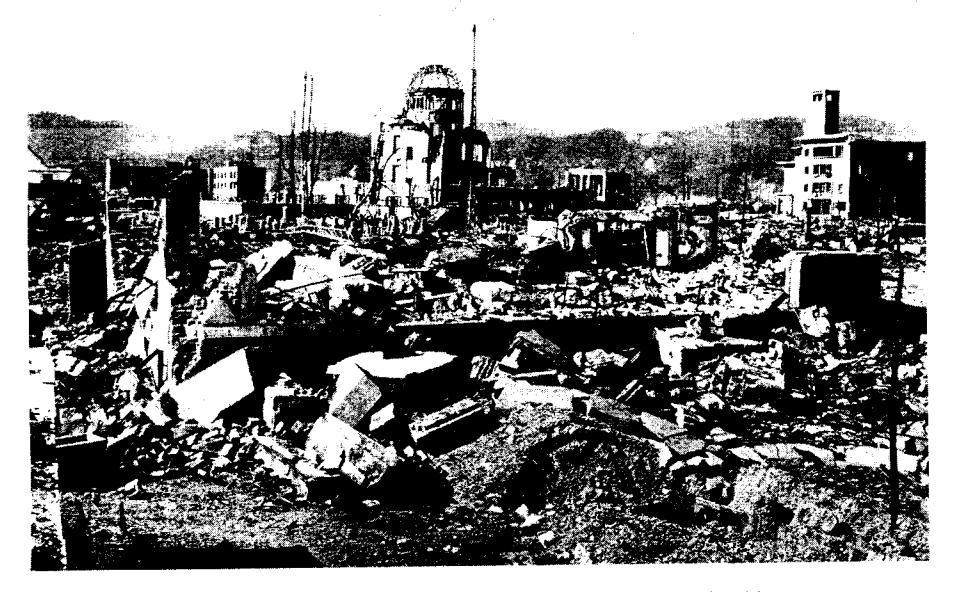
enormous numbers of flying missiles consisting of bricks (and other masonry), glass, pieces of wood and metal, etc. These caused considerable amounts of secondary damage to structures and utilities, and numerous casualties even in the lightly damaged areas. In addition, the large quantities of debris resulted in the blockage of streets, thus making rescue and fire-fighting operations extremely difficult (Fig. 5.06).

Figure 5.06. Debris after the nuclear explosion at Hiroshima.

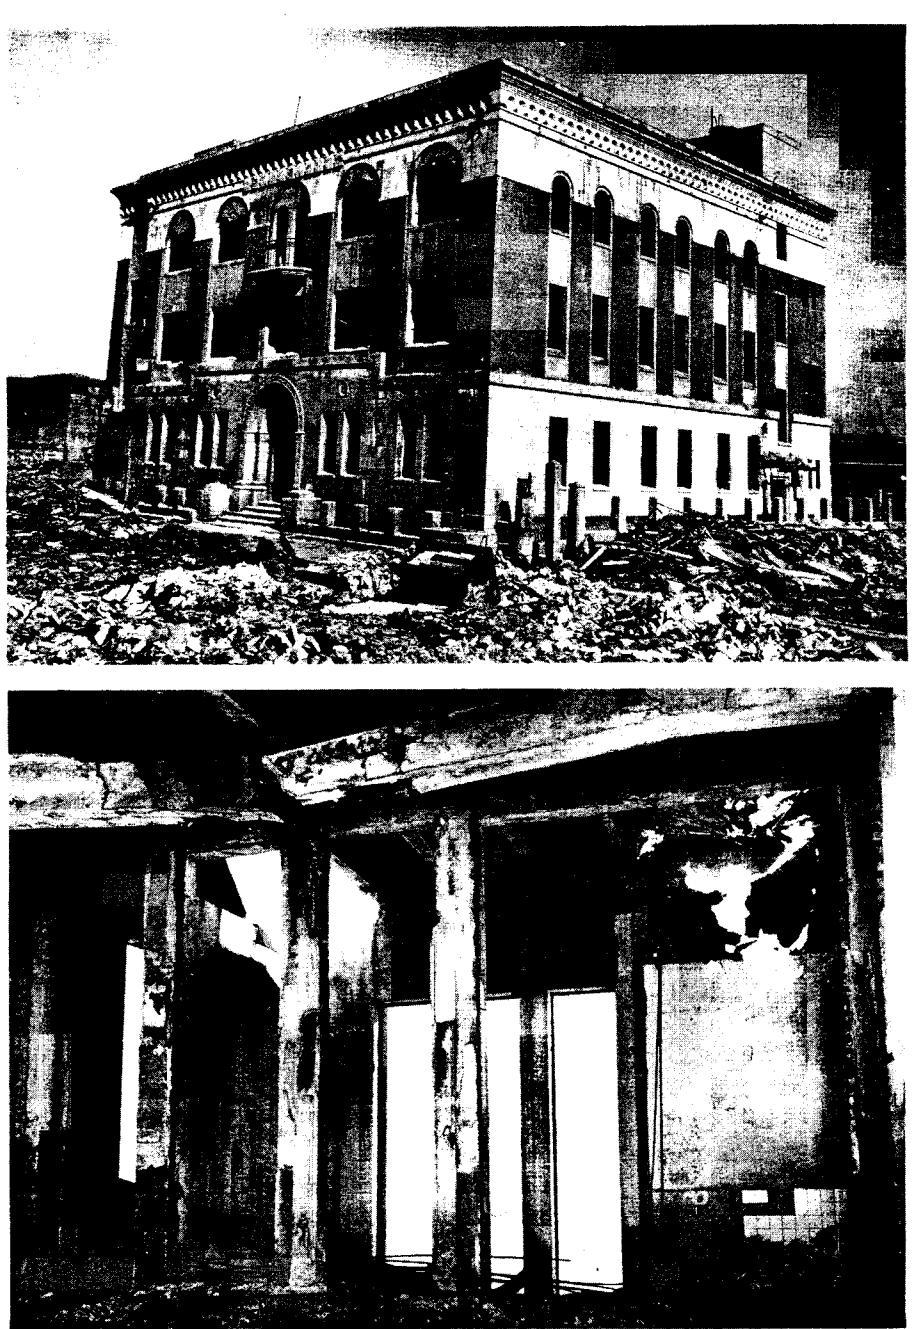
the interior and contents due to the entry of blast through doors and window openings and to subsequent fires. An exceptionally strong structure of earthquake-resistant (aseismic) design, located some 640 feet from ground zero in Hiroshima, is seen in Fig. 5.20a. Although the exterior walls were hardly damaged, the roof was depressed and the interior was destroyed. More typical of reinforced-concrete frame construction in the United States was the building shown in Fig. 5.20b at about the same distance from ground zero. This suffered more severely than the one of aseismic design.

Figure 5.20a. Upper photo: Reinforced-concrete, aseimic structure; window fire shutters were blown in by blast and the interior gutted by fire (0.12 mile from ground zero at Hiroshima). Lower photo: Burned out interior of similar structure.

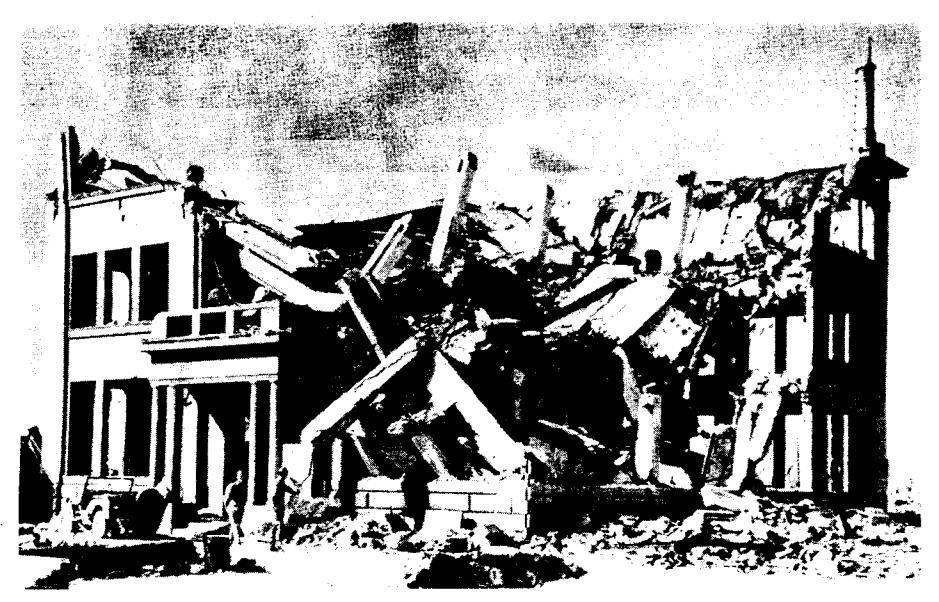
Figure 5.20b. Three-story, reinforced-concrete frame building; walls were 13-inch thick brick panel with large window openings (0.13 mile from ground zero at Hiroshima).

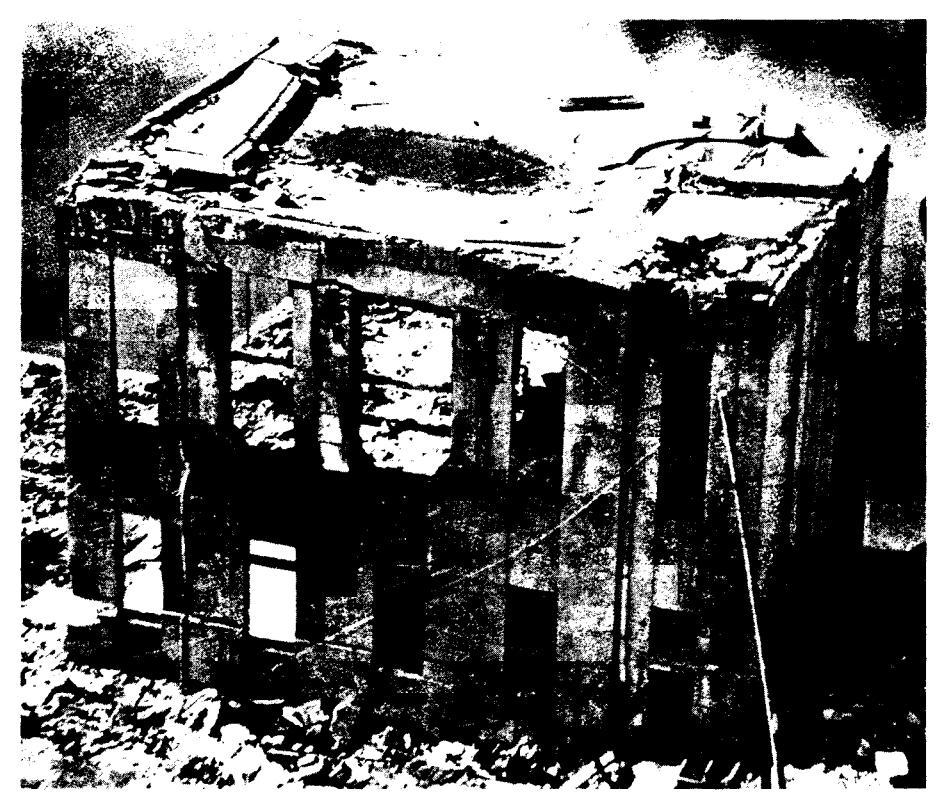
5.22 Close to ground zero the vertical component of the blast was more significant and so greater damage to the roof resulted from the downward force (Fig. 5.22a) than appeared farther away. Depending upon its strength, the roof

was pushed down and left sagging or it failed completely. The remainder of the structure was less damaged than similar buildings farther from the explosion because of the smaller horizontal (lateral) forces. At greater distances, from ground zero, especially in the region of Mach reflection, the consequences of horizontal loading were apparent (Fig. 5.22b).

Figure 5.22a. Depressed roof of reinforced-concrete building (0.10 mile from ground zero at Hiroshima).

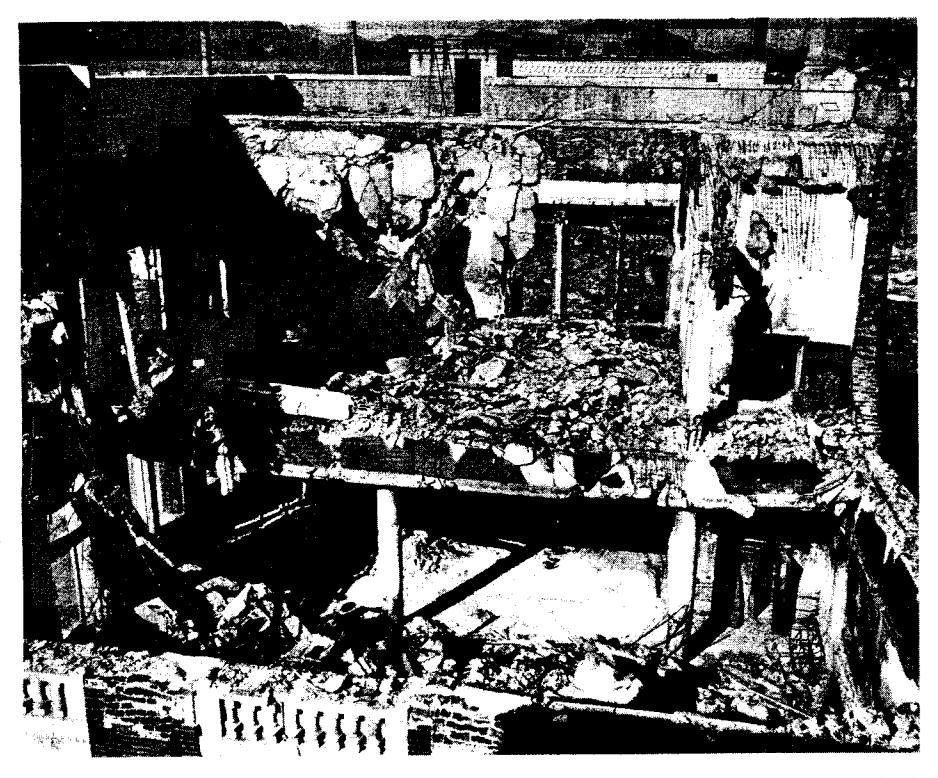
5.23 In addition to the failure of roof slabs and the lateral displacement of walls, numerous other blast effects were observed. These included bending and fracture of beams, failure of columns, crushing of exterior wall panels, and failure of floor slabs (Fig. 5.23). Heavy damage to false ceilings, plaster, and partitions occurred as far out as 9,000 feet (1.7 miles) from ground zero, and glass windows were generally bro-

Figure 5.23. Reinforced-concrete building showing collapsed roof and floor slabs (0.10 mile from ground zero at Nagasaki).

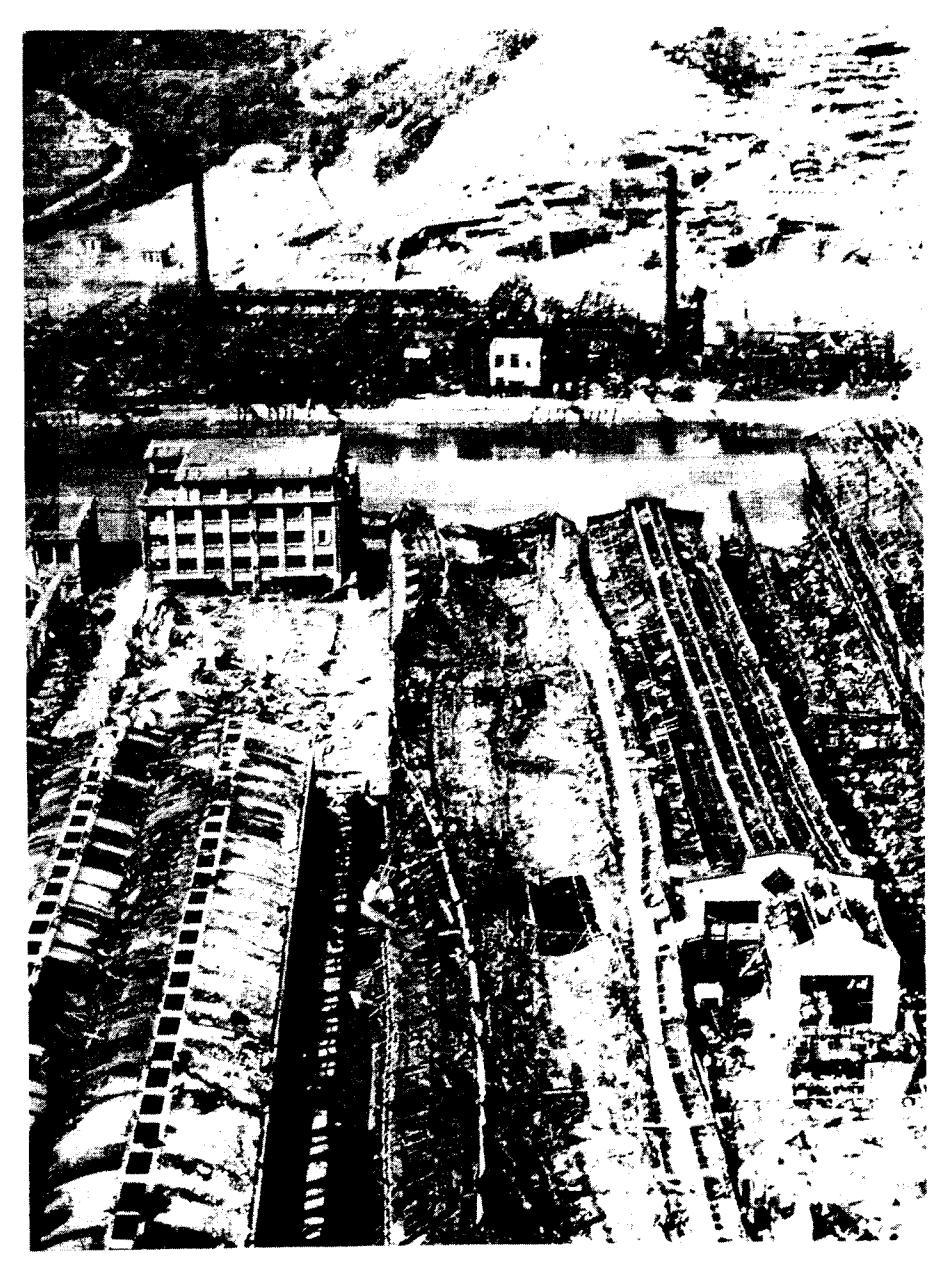
ground zero (Fig. 5.25). The only part of the building that was not regarded as being of heavy construction was the roof, which was of 4-inch thick reinforced concrete supported by unusually light steel trusses. The downward failure of the roof, which was dished 3 feet, was the only important structural damage suffered.

Figure 5.25. At left and back of center is a multistory, steel-frame building (0.85 mile from gound zero at Nagasaki).

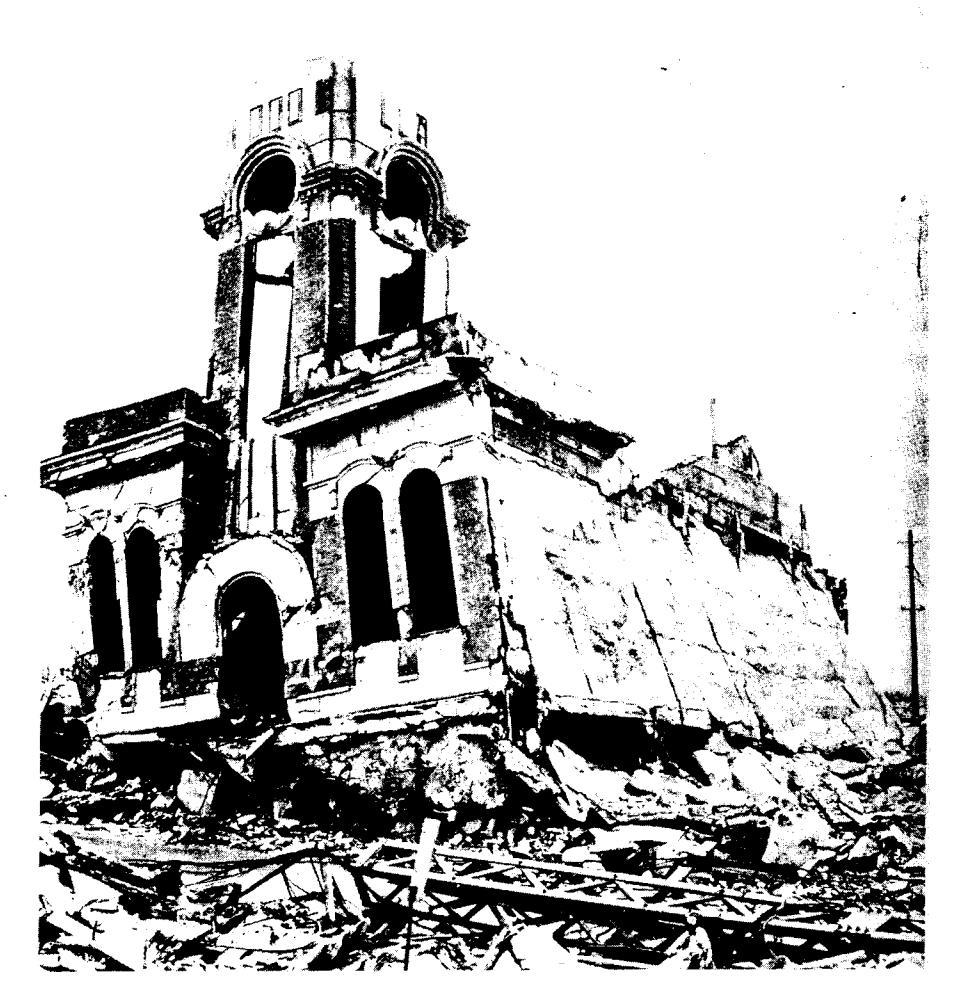
Figure 5.26. Two-story, steel-frame building with 7-inch reinforced-concrete wall panels (0.40 mile from ground zero at Hiroshima). The first story columns buckled away from ground zero dropping the second story to the ground.

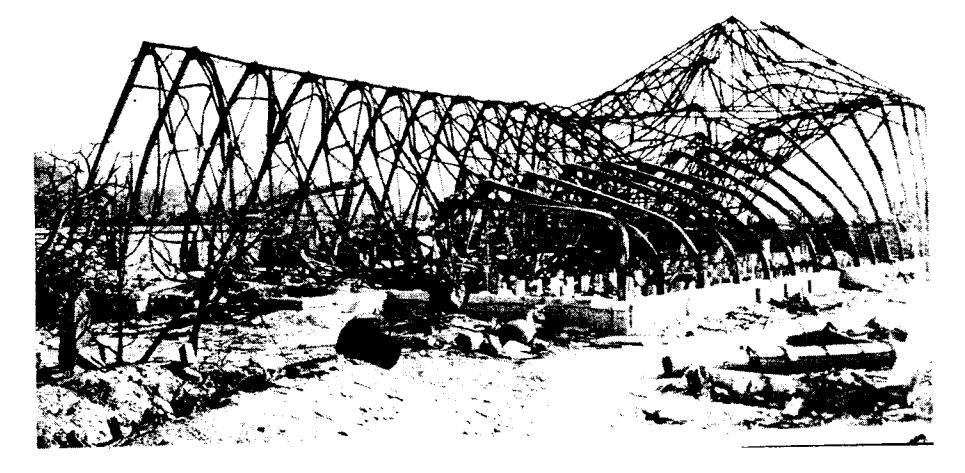
5.29 Severe damage of these structures occurred up to a distance of about 6,000 feet (1.14 miles) from ground zero. Moderately close to ground zero, the buildings were pushed over bodily, and at greater distances they were generally left leaning away from the source of the blast (Fig. 5.29). The columns being long and slender offered little resistance to the lateral loading. Sometimes columns failed due to a lateral force causing flexure, combined with a simultaneous small increase in the downward load coming from the impact of the blast on the roof. This caused buckling and, in some instances, complete collapse. Roof trusses were buckled by compression resulting from lateral blast loading on the side of the building facing the explosion.

Figure 5.29. Single-story, light steel-frame building (0.80 mile from ground zero at Hiroshima); partially damaged by blast and further collapsed by subsequent fire.

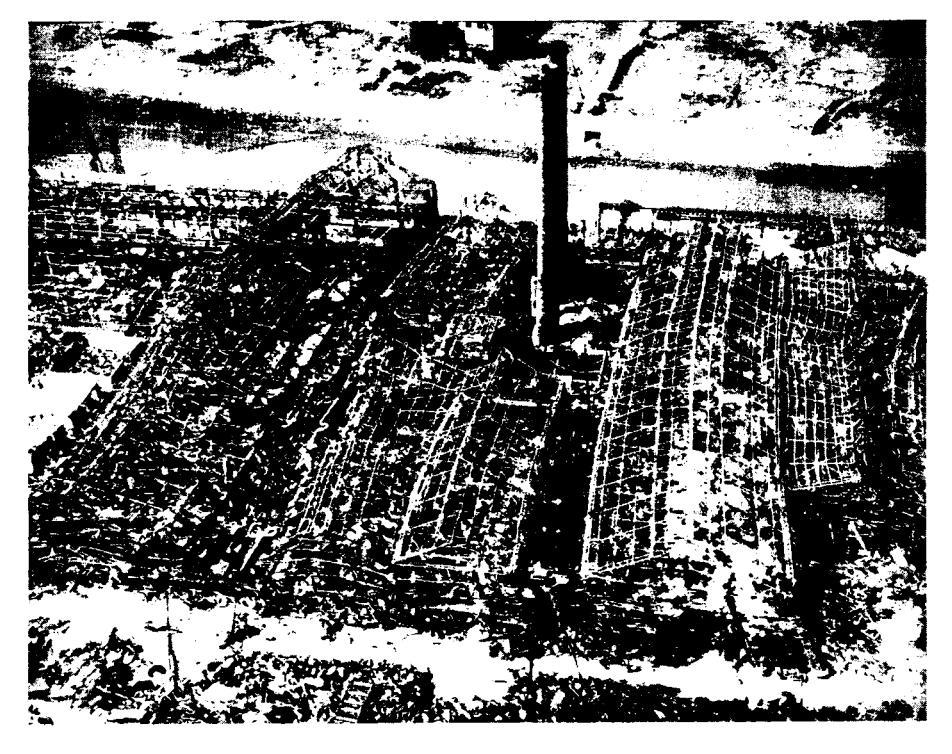
Smokestacks, especially those 5.34 of reinforced concrete, proved to have considerable blast resistance (Fig. 5.34a). Because of their shape, they are subjected essentially to drag loading only and, if sufficiently strong, their long period of vibration makes them less sensitive to blast than many other structures. An example of extreme damage to a reinforced-concrete stack is shown in Fig. 5.34b. Steel smokestacks performed reasonably well, but being lighter in weight and subject to crushing were not comparable to reinforced concrete. On the whole, well-constructed masonry stacks withstood the blast somewhat better than did those made of steel.

Figure 5.34a. Destroyed industrial area showing smokestacks still standing (0.51 mile from ground zero at Nagasaki).

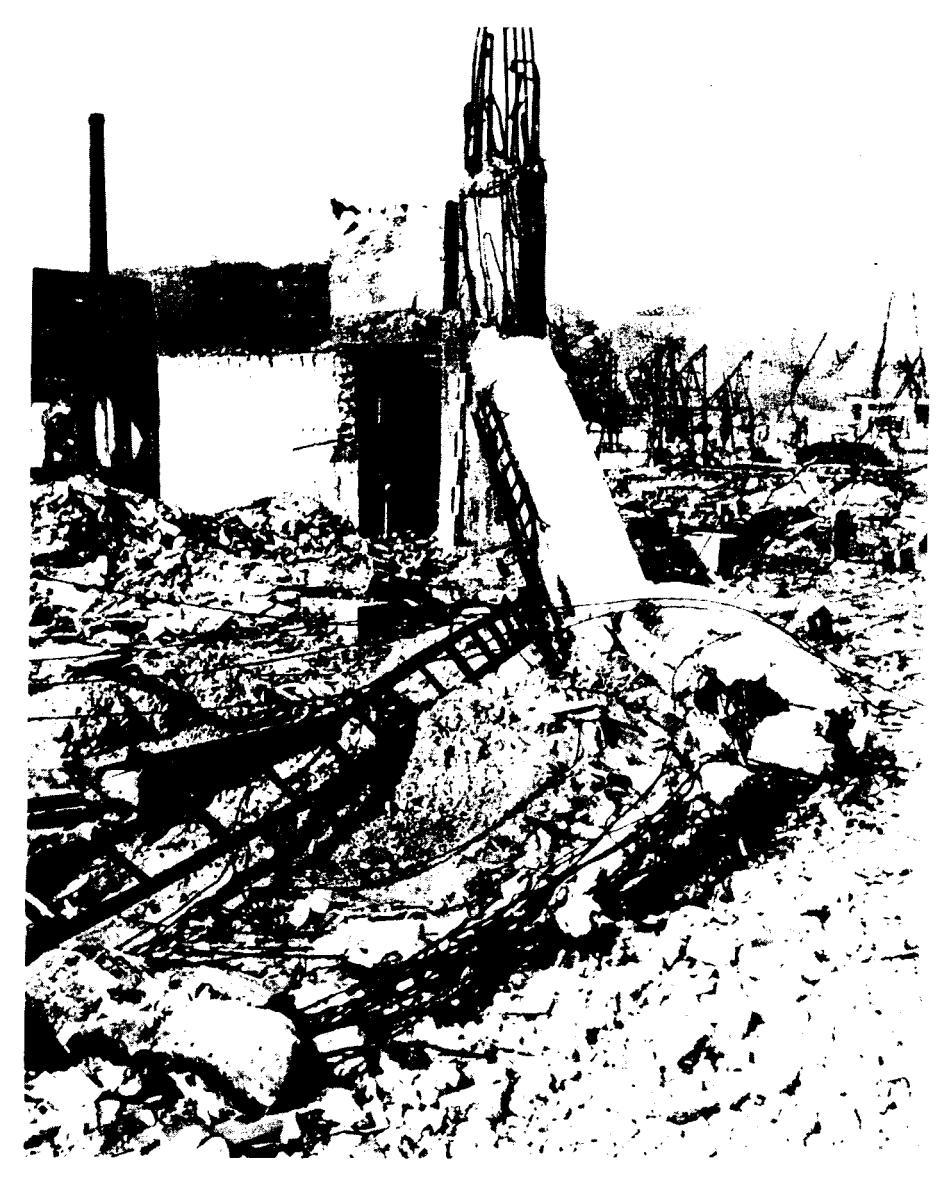
Figure 5.34b. A circular, 60 feet high, reinforced-concrete stack (0.34 mile from ground zero at Hiroshima). The failure caused by the blast wave occurred 15 feet above the base.

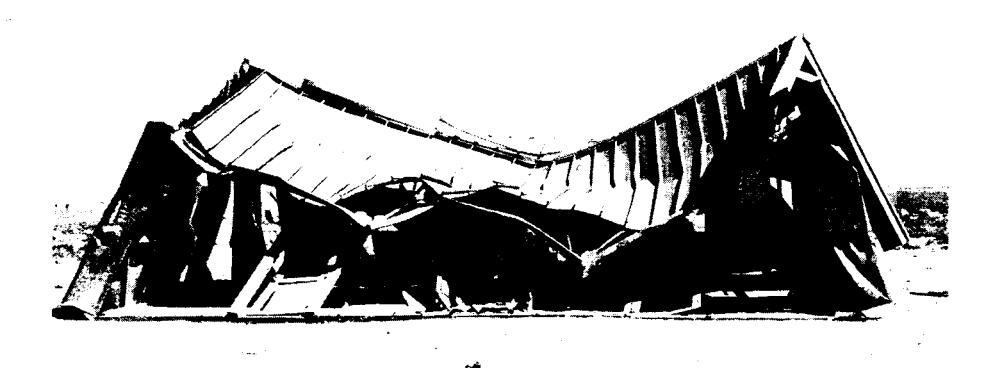
> 0.2 pound per square inch) was completely demolished (Fig. 5.40b). One or two segments of wall were blown as far as 50 feet away, but, in general, the bent and twisted segments of the building remained approximately in their original locations. Most of the wall sections were still attached to their foundation bolts on the side and rear walls of the

Figure 5.40b. Self-framing steel panel building after a nuclear explosion (3.1 psi peak overpressure).

5.42 It appears that the steel panel type of structure is repairable if exposed to overpressures of not more than about $\frac{3}{4}$ to 1 pound per square inch. The buildings are simple to construct but they do not hold together well under

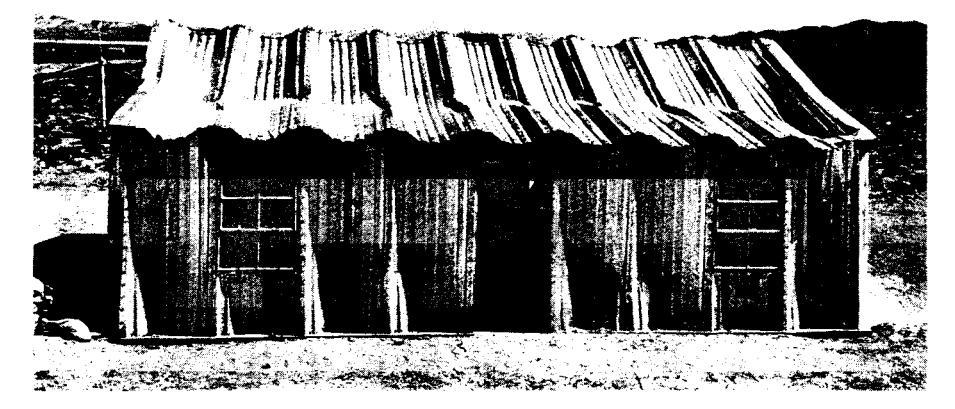
Figure 5.44. Self-framing corrugated steel panel building after a nuclear explosion (3.1 psi peak overpressure).

5.44 At a peak overpressure of 3.1 and a dynamic pressure of 0.2 pound per square inch a structure of this type was badly damaged, but all the pieces remained bolted together, so that the structure still provided good protection from the elements for its contents. The front slope of the roof was crushed downward, from 1 to 2 feet, at midsection, and the ridge line suffered moderate deflection. The rear slope of the roof appeared to be essentially undamaged (Fig. 5.44).

5.45 The front and side walls were buckled inward several inches, and the door in the front was broken off. All the windows were damaged to some extent, although a few panes in the rear remained in place.

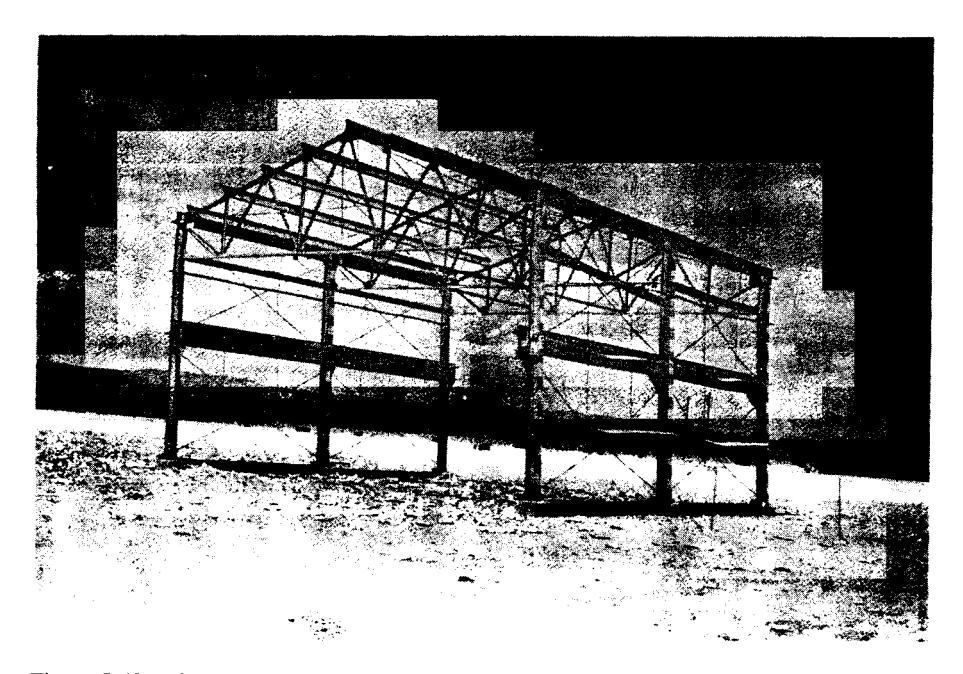
Figure 5.49. Structure in Figure 5.48a after exposure to 6.5 psi peak overpressure and 1.1 psi dynamic pressure; positive phase duration 0.9 second.

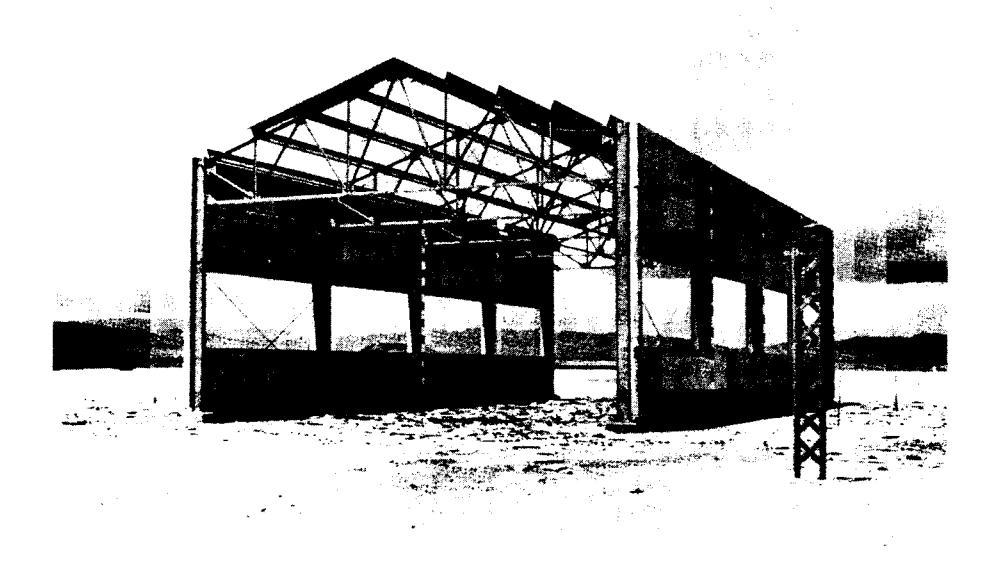
Figure 5.50. Structure in Figure 5.48b after exposure to 3.5 psi peak overpressure and 0.3 psi dynamic pressure; positive phase duration 1 second.

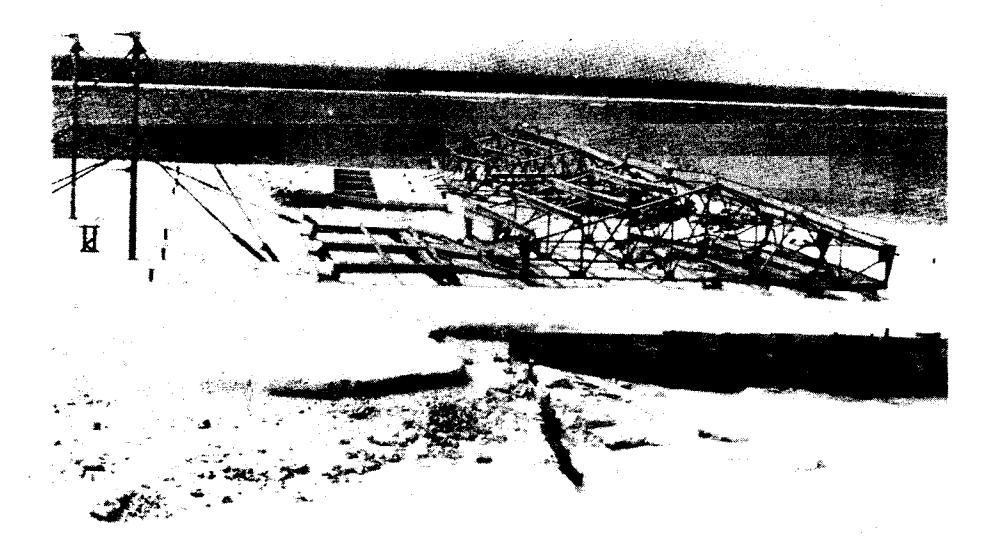
Figure 5.51a. Structure similar to Figure 5.48a after exposure to 6.1 psi peak overpressure and 0.6 psi dynamic pressure; positive phase duration several seconds.

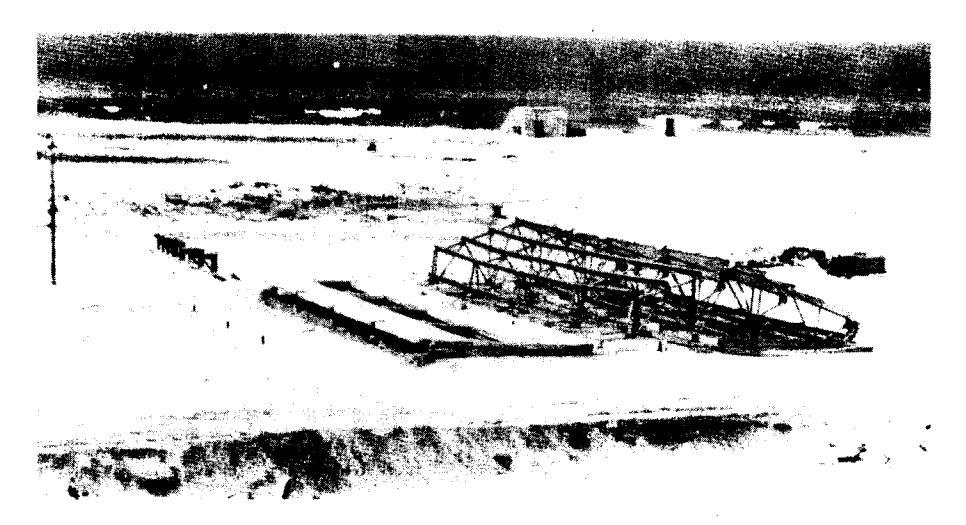
Figure 5.51b. Structure similar to Figure 5.48b after exposure to 5 psi peak overpressure and 0.5 psi dynamic pressure; positive phase duration several seconds.

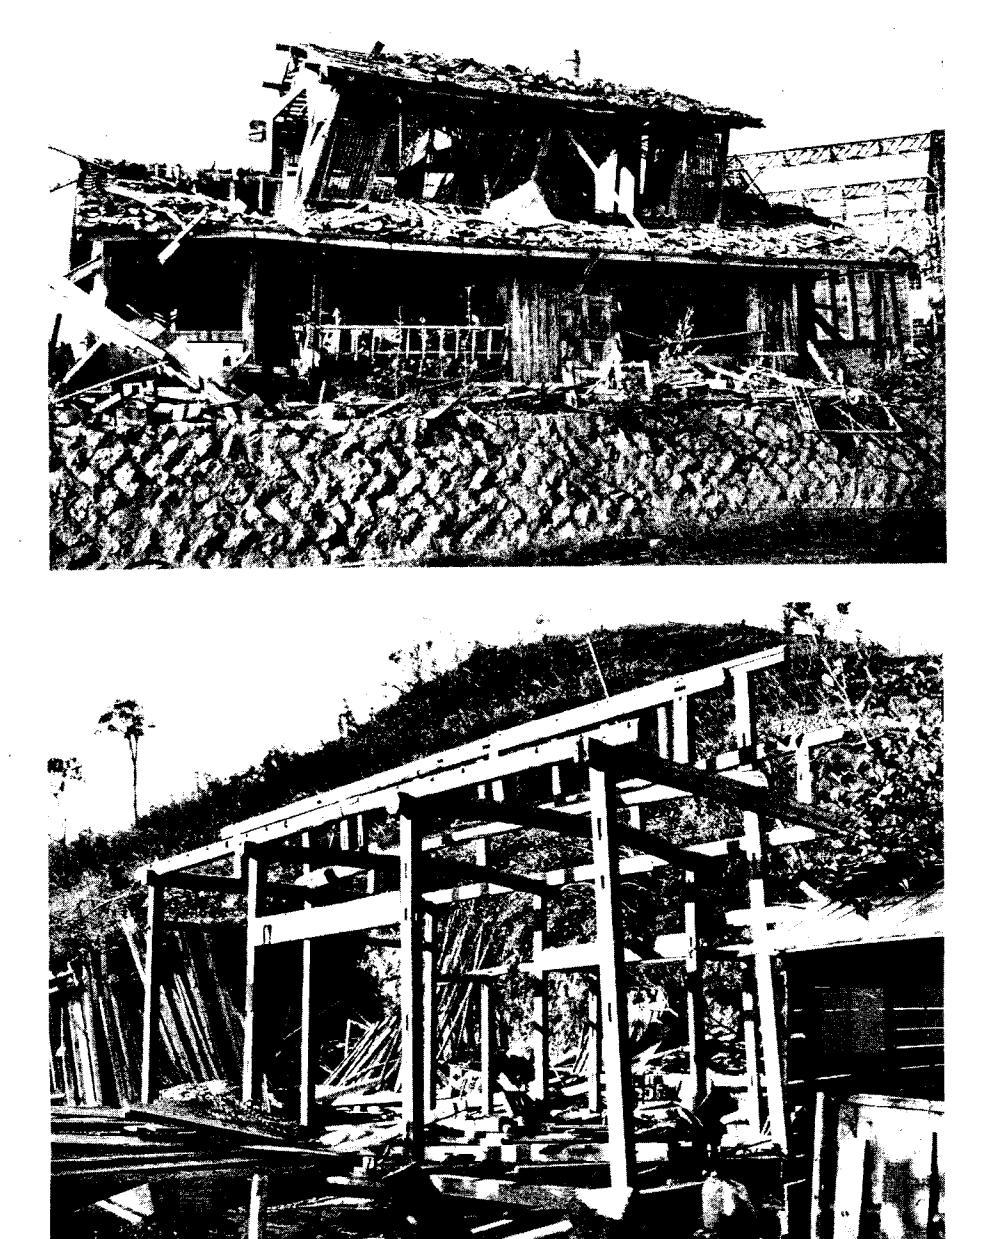
5.52 There were many woodframed residential structures with adobe walls in the Japanese cities which were subjected to nuclear attack, but such a large proportion were destroyed by fire that very little detailed information concerning blast damage was obtained. It appeared that, although the quality of the workmanship in framing was usually high, little attention was paid to good engineering principles. On the whole, therefore, the construction was not well adapted to resist wracking action (distortion). For example, mortise and tenon joints were weak points in the

Figure 5.52. Upper photo; Wood-frame building; 1.0 mile from ground zero at Hiroshima. Lower photo: Frame of residence under construction, showing small tenons.

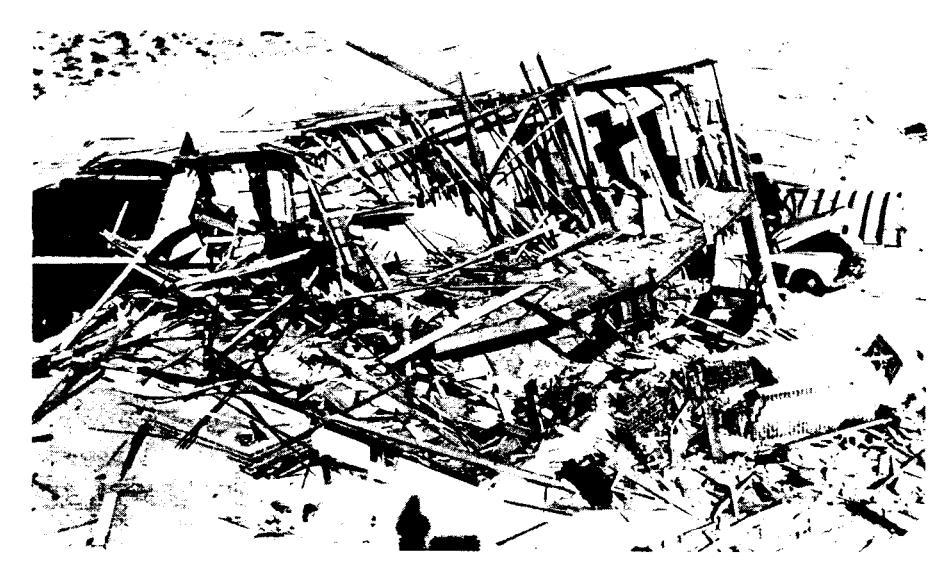
5.57 Some indication of the blast damage suffered by this dwelling can be obtained from Fig. 5.57. It is apparent that the house was ruined beyond repair. The first story was completely demolished and the second story, which was very badly damaged, dropped down on the first floor debris. The roof was blown off in several sections which landed at both front and back of the house. The gable end walls were blown apart and outward, and the brick chimney was broken into several pieces.

Figure 5.57. Wood-frame house after a nuclear explosion (5 psi peak overpressure).

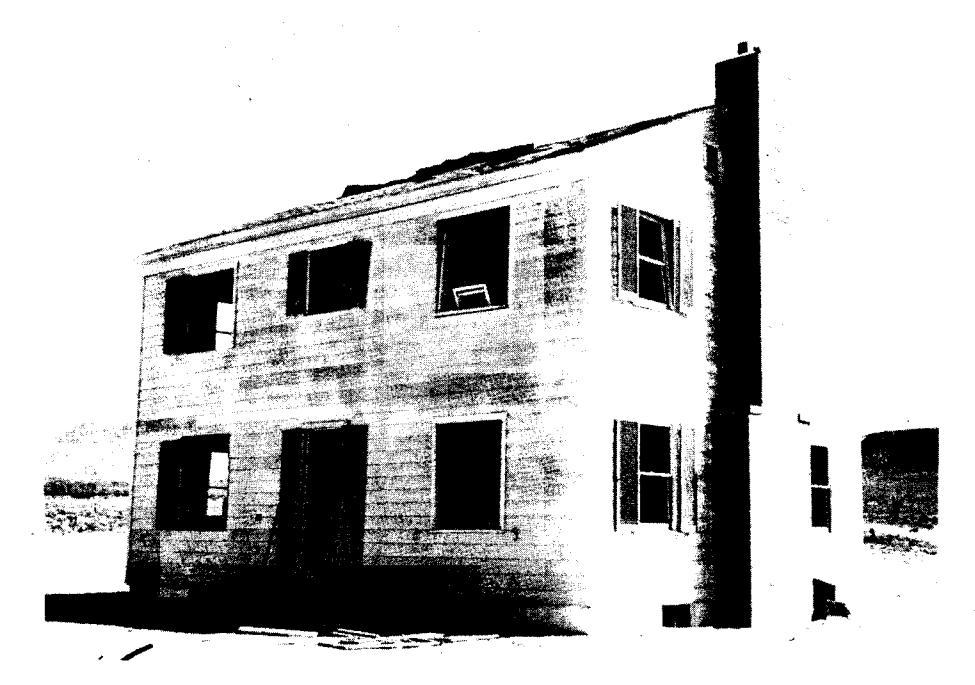
Figure 5.59. Wood-frame house after a nuclear explosion (1.7 psi peak overpressure).

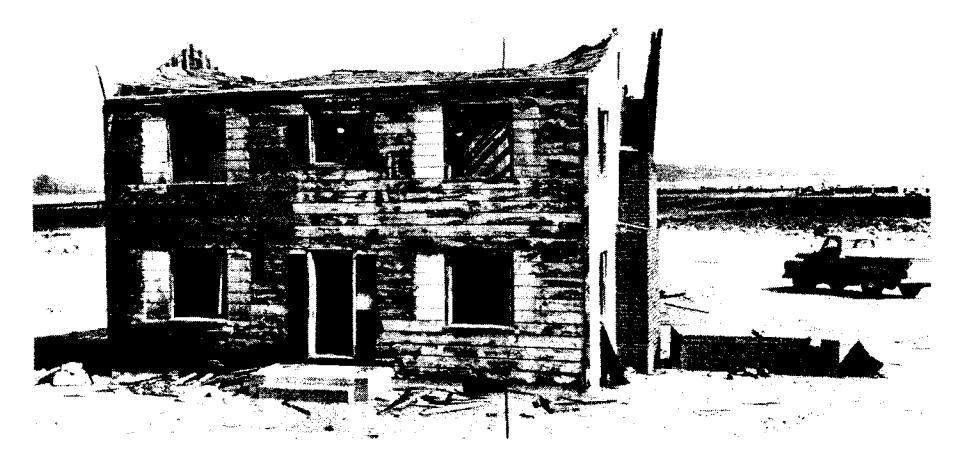
Figure 5.64. Strengthened wood-frame house after a nuclear explosion (4 psi peak overpressure).

5.64 Even with these improvements, it was expected that almost complete destruction would occur at 5 pounds per square inch peak overpressure, and so one of the houses was located where the overpressure at the Mach front would be 4 pounds per square inch. Partly because of the increased strength and partly because of the lower air blast pressure the house did not collapse (Fig. 5.64). But the superstructure was so badly damaged that it could not have been occupied without expensive repair which would not have been economically advisable.

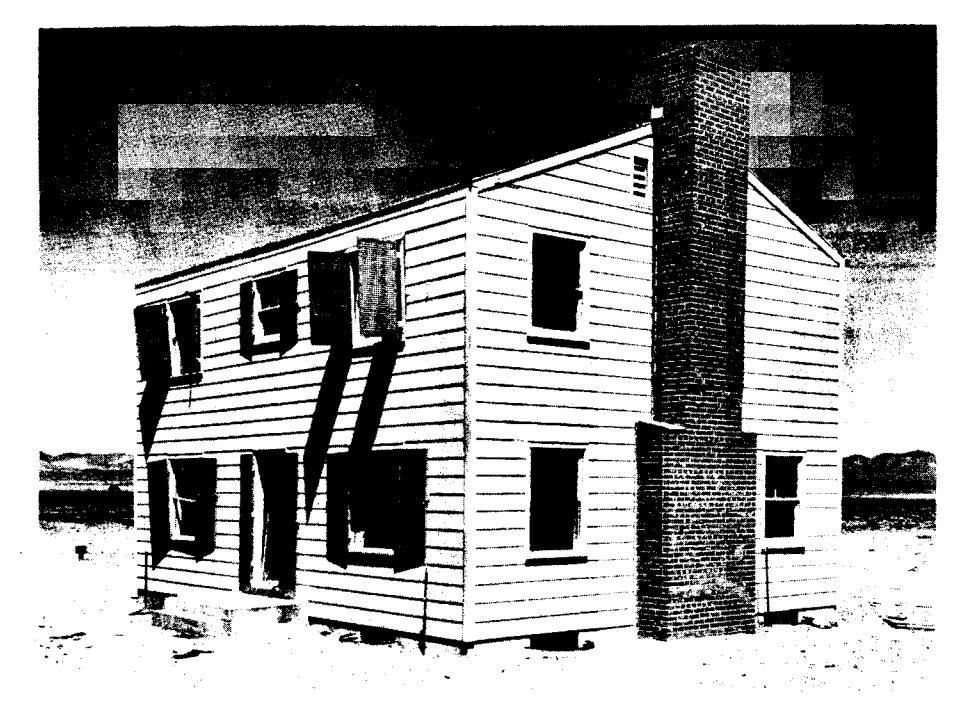
Figure 5.65. Strengthened wood-frame house after a nuclear explosion (2.6 psi peak overpressure).

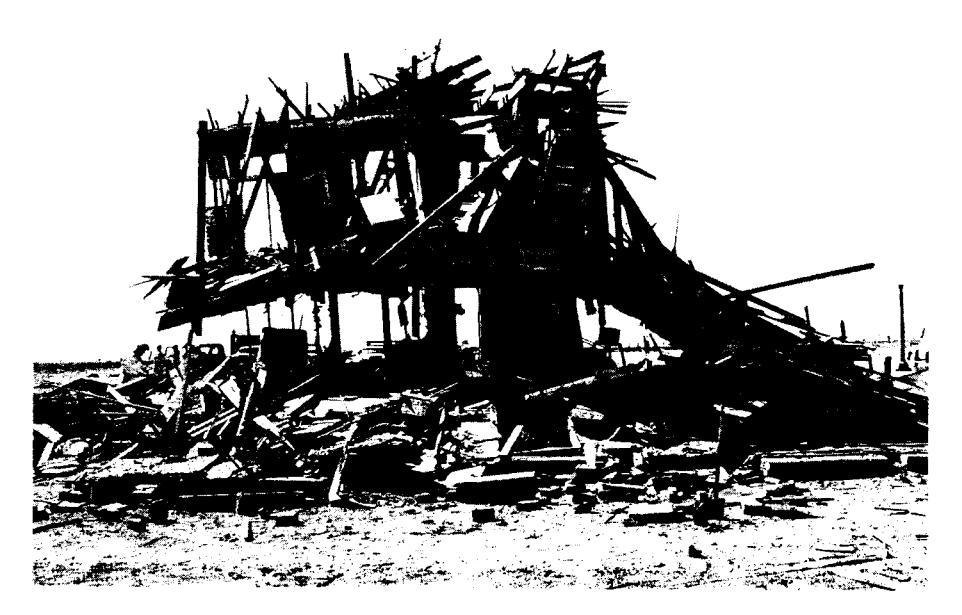
5.67 At an incident peak overpressure of 5 pounds per square inch, the brick-wall house was damaged beyond

Figure 5.67. Unreinforced brick house after a nuclear explosion (5 psi peak overpressure).

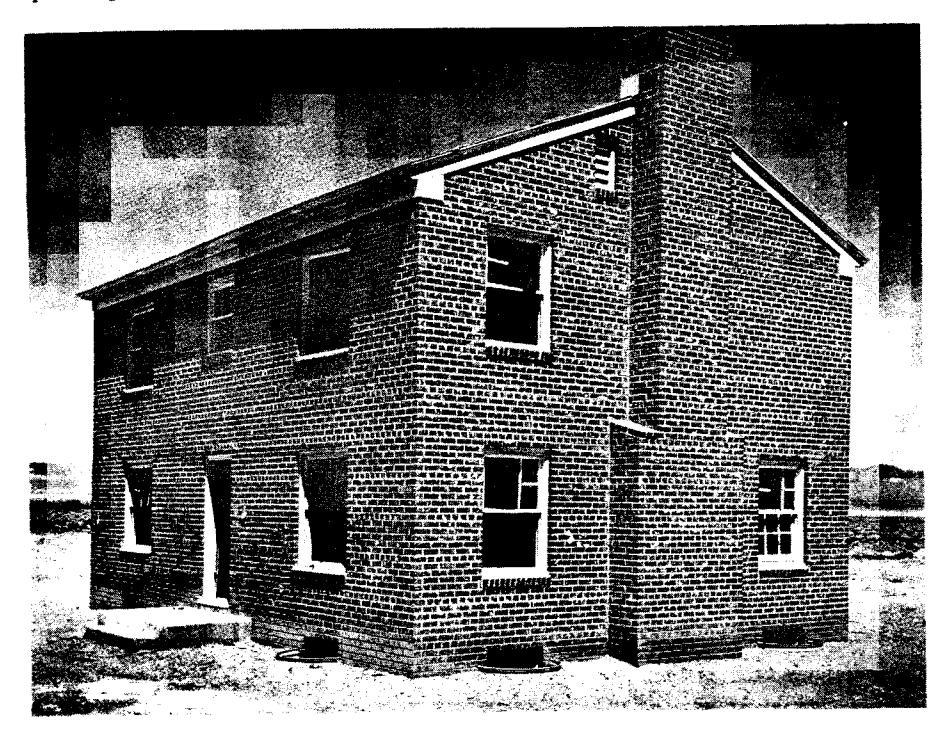
Figure 5.68. Unreinforced brick house after a nuclear explosion (1.7 psi peak overpressure).

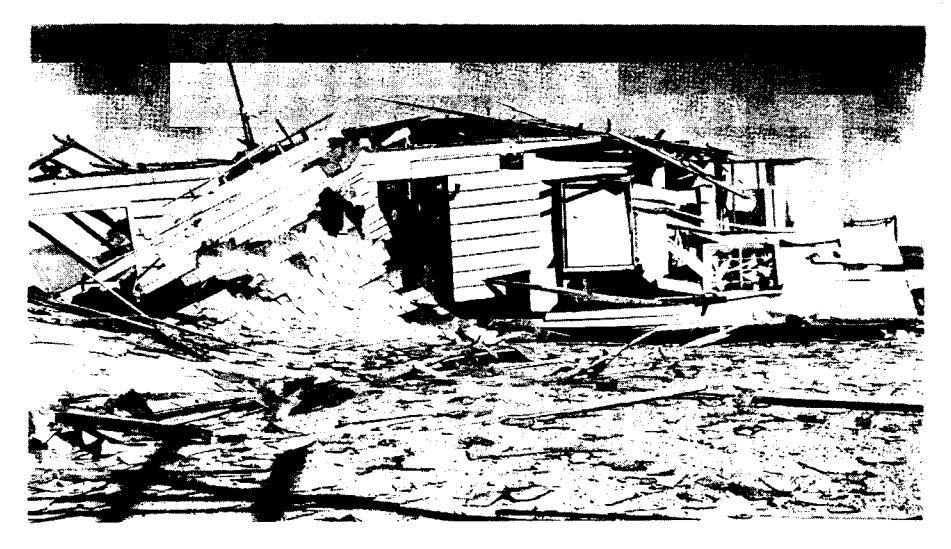
Figure 5.70. Rambler-type house after a nuclear explosion (5 psi peak overpressure).

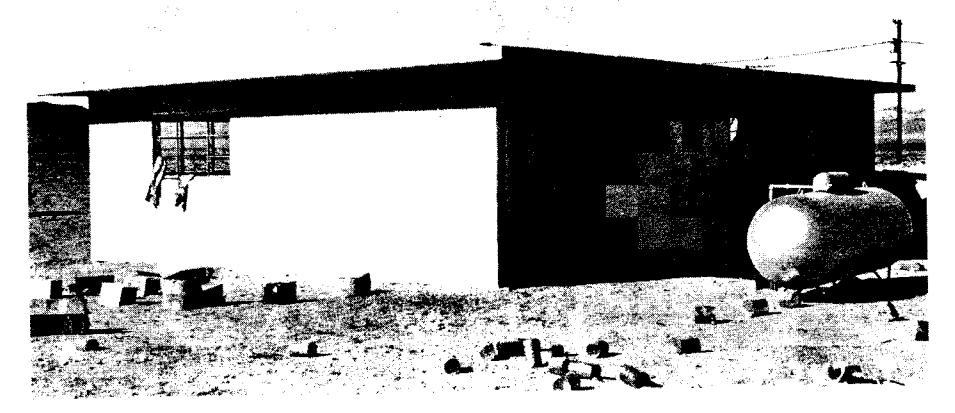
Figure 5.73. Reinforced precast concrete house after a nuclear explosion (5 psi peak overpressure). The LP-gas tank, sheltered by the house, is essentially undamaged.

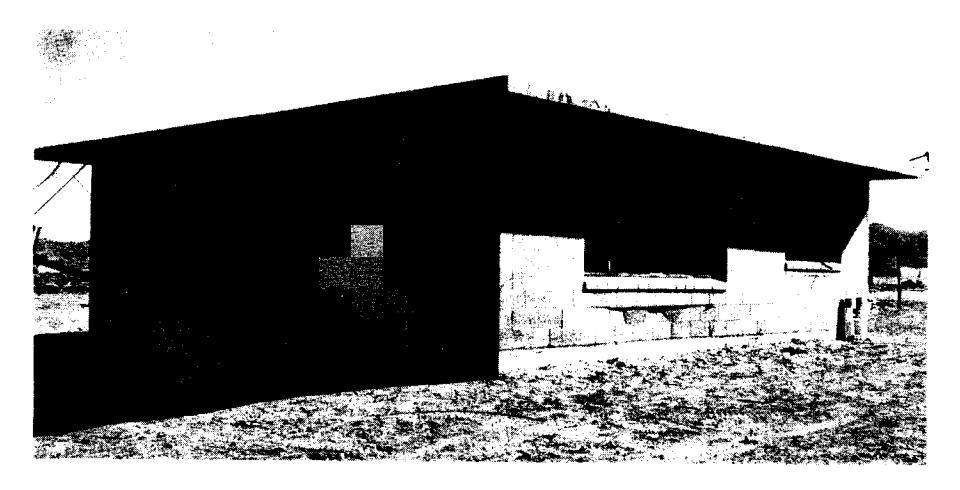
Figure 5.77. Reinforced masonry-block house after a nuclear explosion (5 psi peak overpressure).

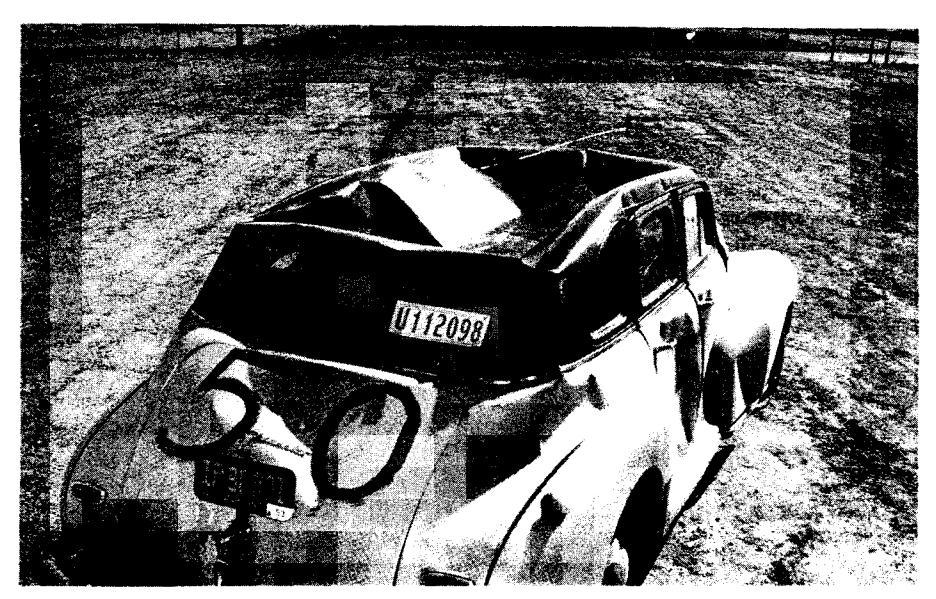
Figure 5.87a. Damage to automobile originally located behind wood-frame house (5 psi peak overpressure); the front of this car can be seen in Figure 5.57. Although badly damaged, the car could still be driven after the explosion.

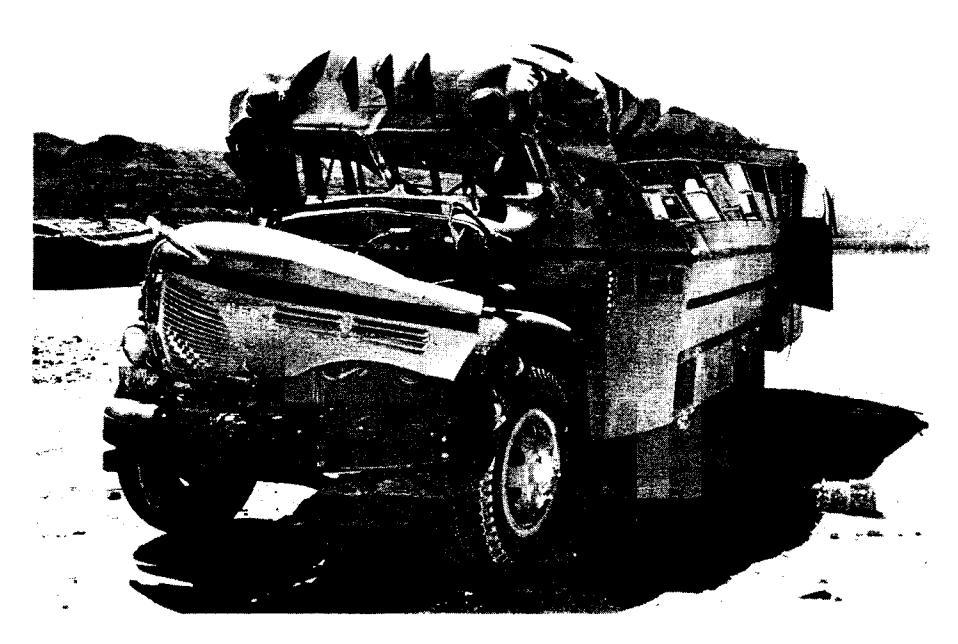
Figure 5.87b. Typical public bus damaged by a nuclear explosion, Nevada Test Site; this bus, like the one in the left background, was overturned, coming to rest as shown after a displacement of 50 feet.

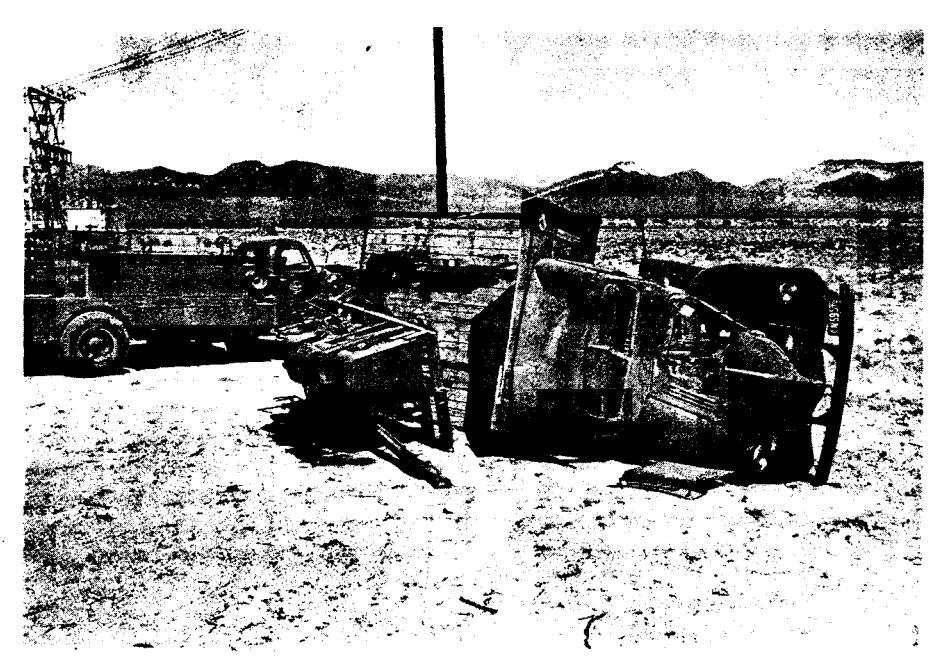
Figure 5.89. Truck broadside to the blast wave (5 psi peak overpressure) overturned; electric utility truck in background head-on to blast was damaged but remained standing.

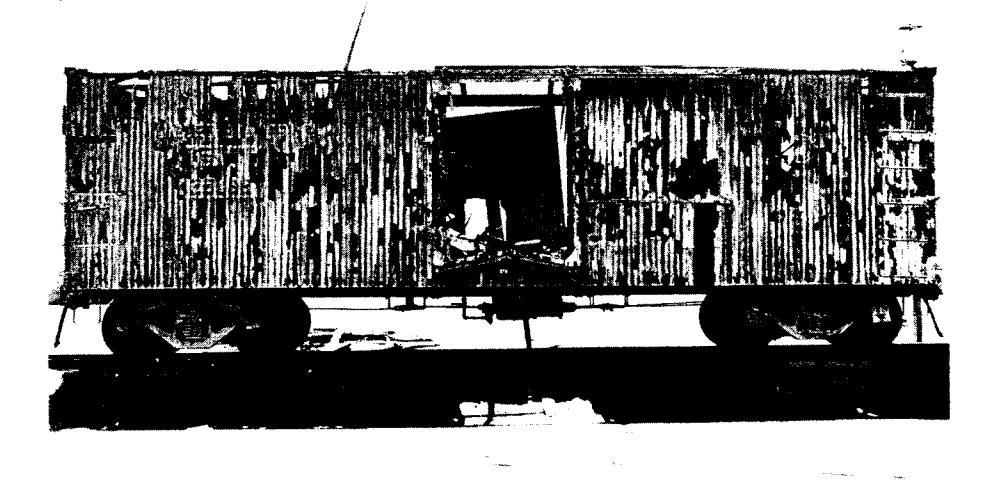
Figure 5.92a. Loaded wooden boxcar after a nuclear explosion (4 psi peak overpressure).
