CHAPTER V

STRUCTURAL DAMAGE FROM AIR BLAST

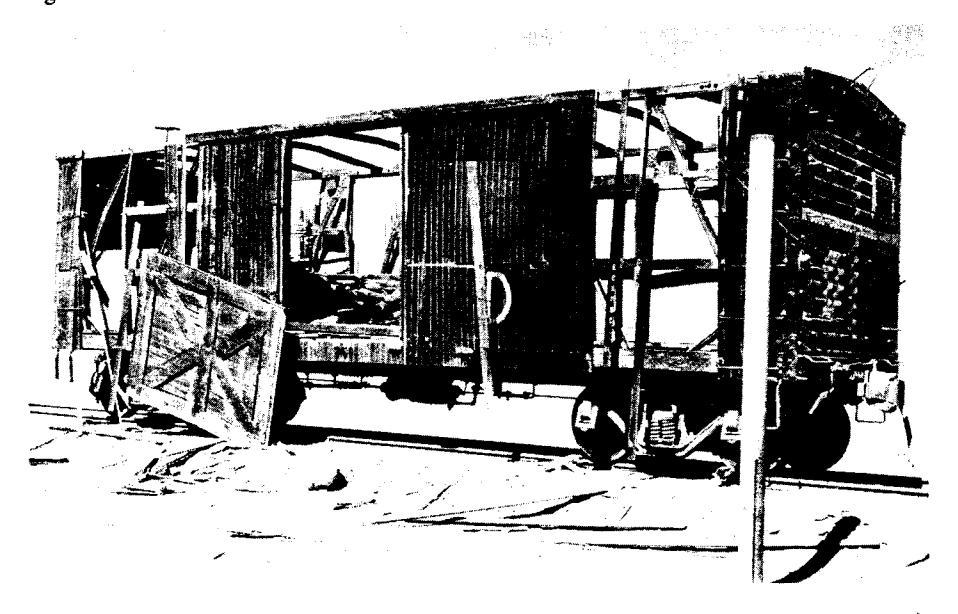
Figure 5.92b. Loaded wooden boxcar after a nuclear explosion (6 psi peak overpressure).

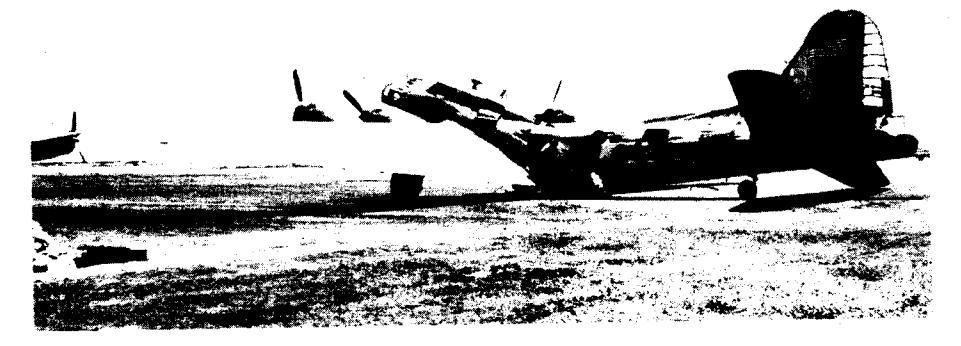
Figure 5.95a. Aircraft after side exposed to a nuclear explosion (3.6 psi peak overpressure).

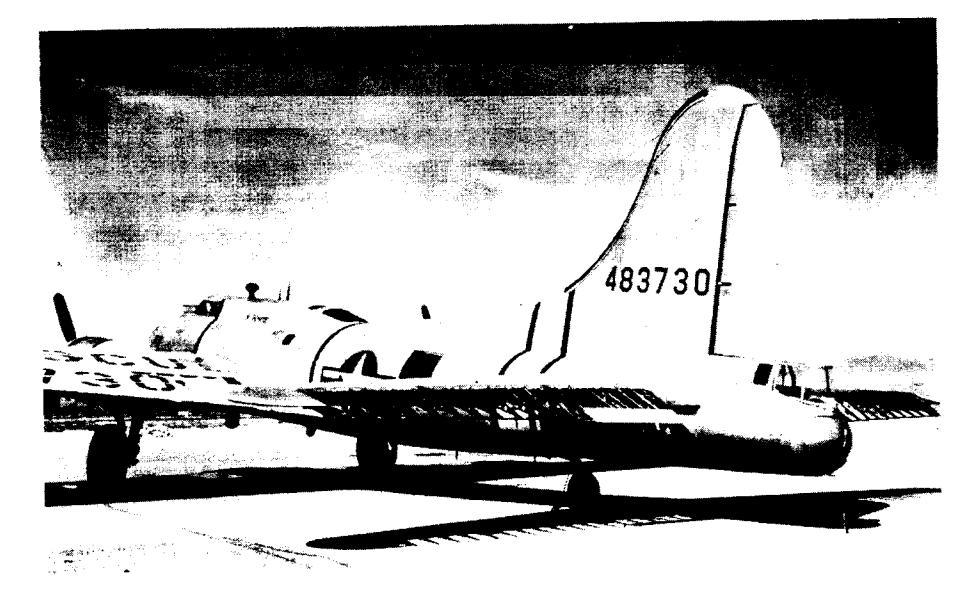
Figure 5.95b. Aircraft after tail exposed to a nuclear explosion (2.4 psi peak overpressure).

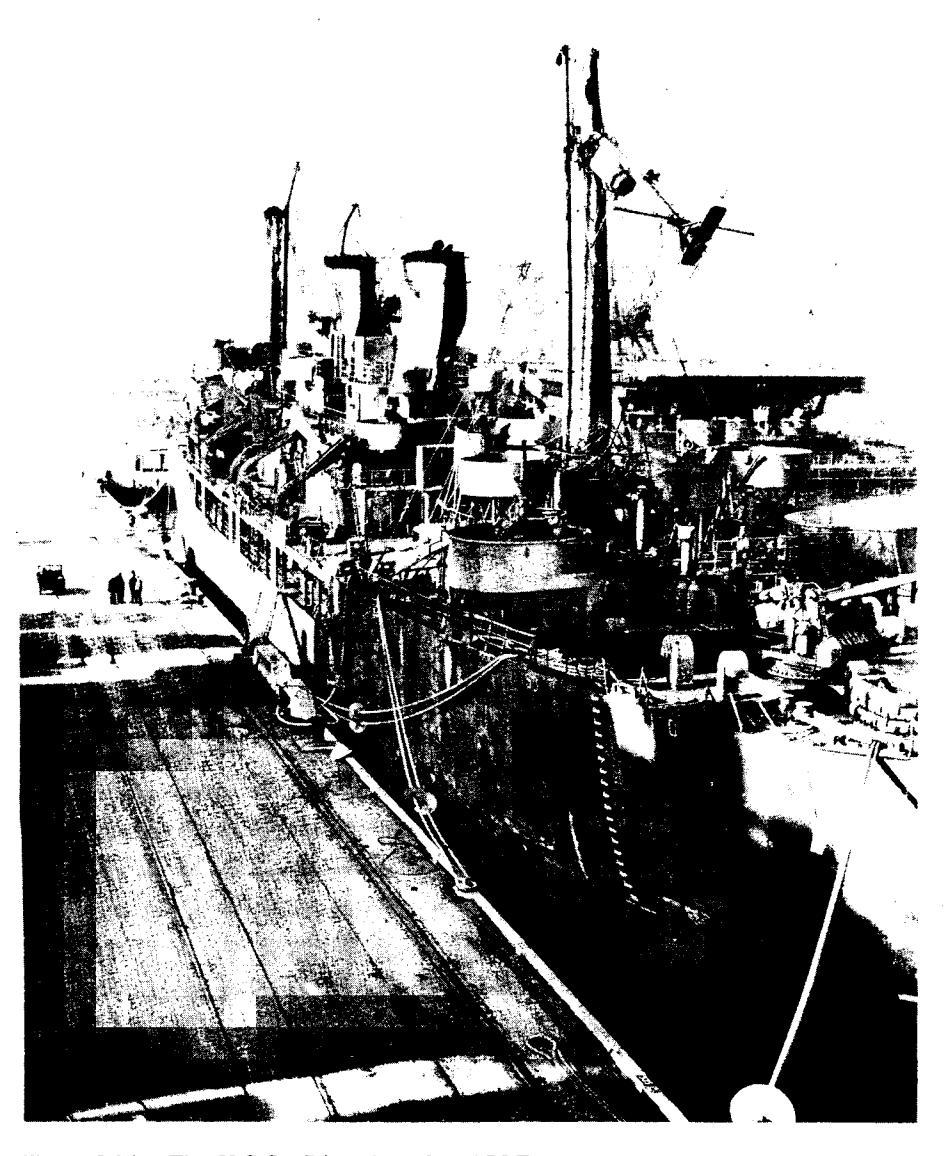
Figure 5.96. The U.S.S. Crittenden after ABLE test; damage resulting was generally serious (0.47 mile from surface zero).

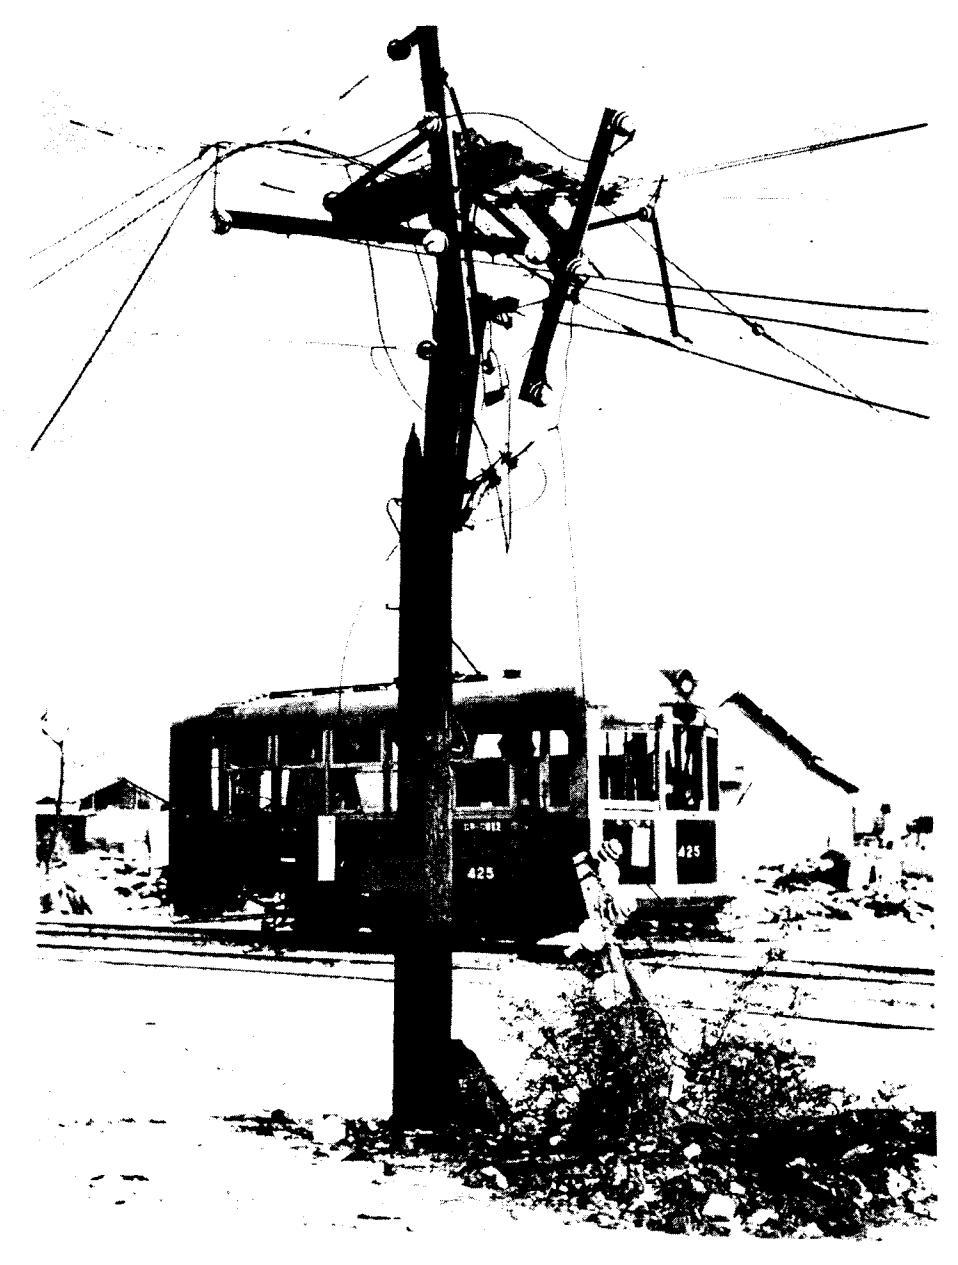
Figure 5.98. Damage to utility pole (0.80 mile from ground zero at Hiroshima).

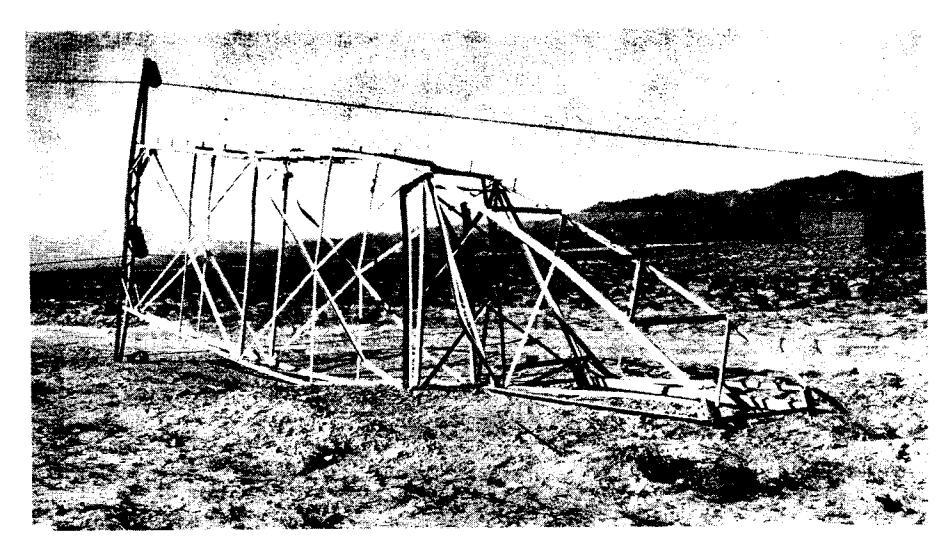
Figure 5.102a. Collapsed suspension tower (5 psi peak overpressure, 0.6 psi dynamic pressure from 30-kiloton explosion), Nevada Test Site.

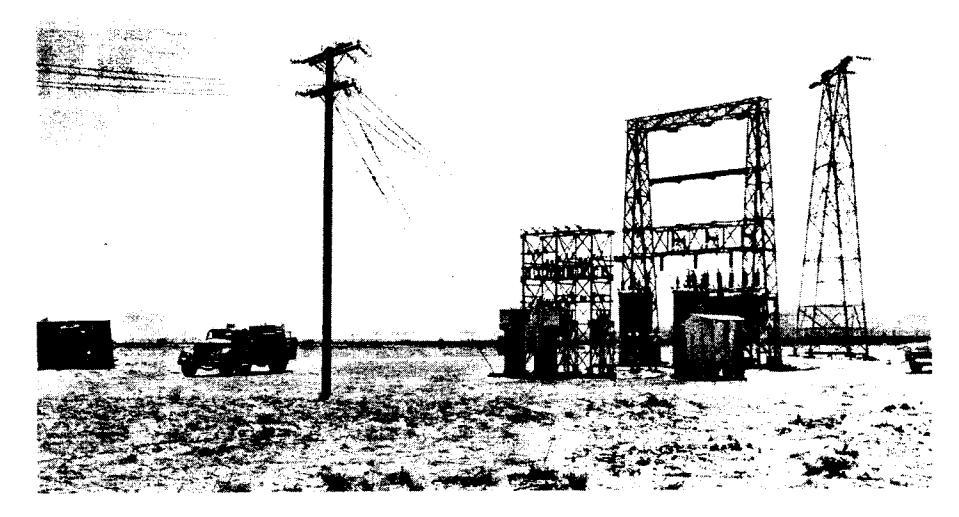
Figure 5.102b. Dead-end tower, suspension tower, and transformers (5 psi peak overpressure, 0.6 psi dynamic pressure from 30-kiloton explosion), Nevada Test Site. The trucks at the left of the photograph are those in Figure 5.89.

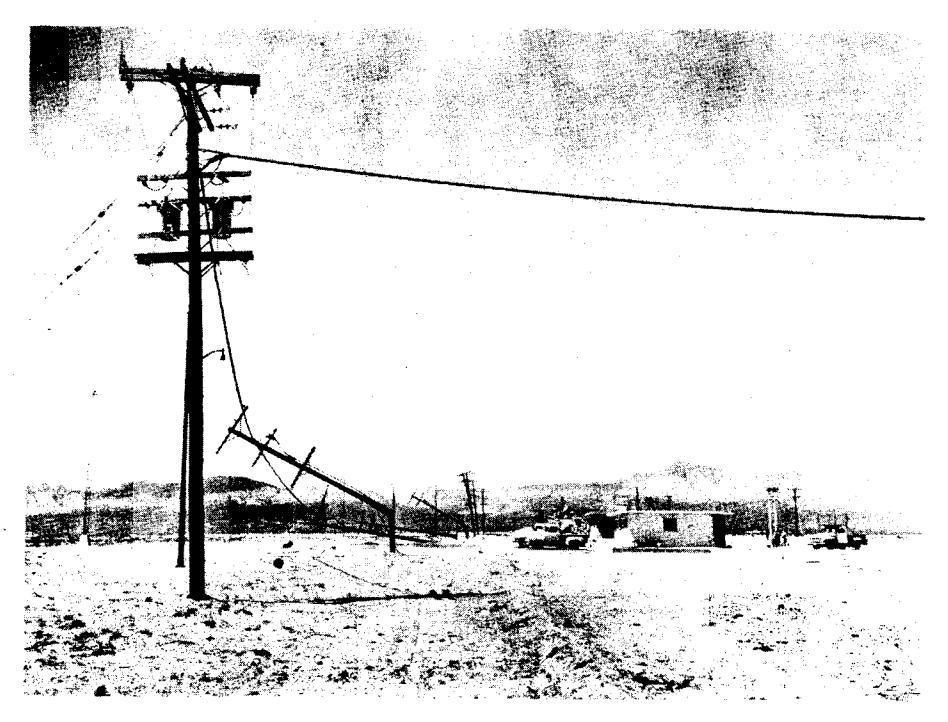
Figure 5.104. Collapse of utility poles on line (5 psi peak overpressure, 0.6 psi dynamic pressure from 30-kiloton explosion), Nevada Test Site.

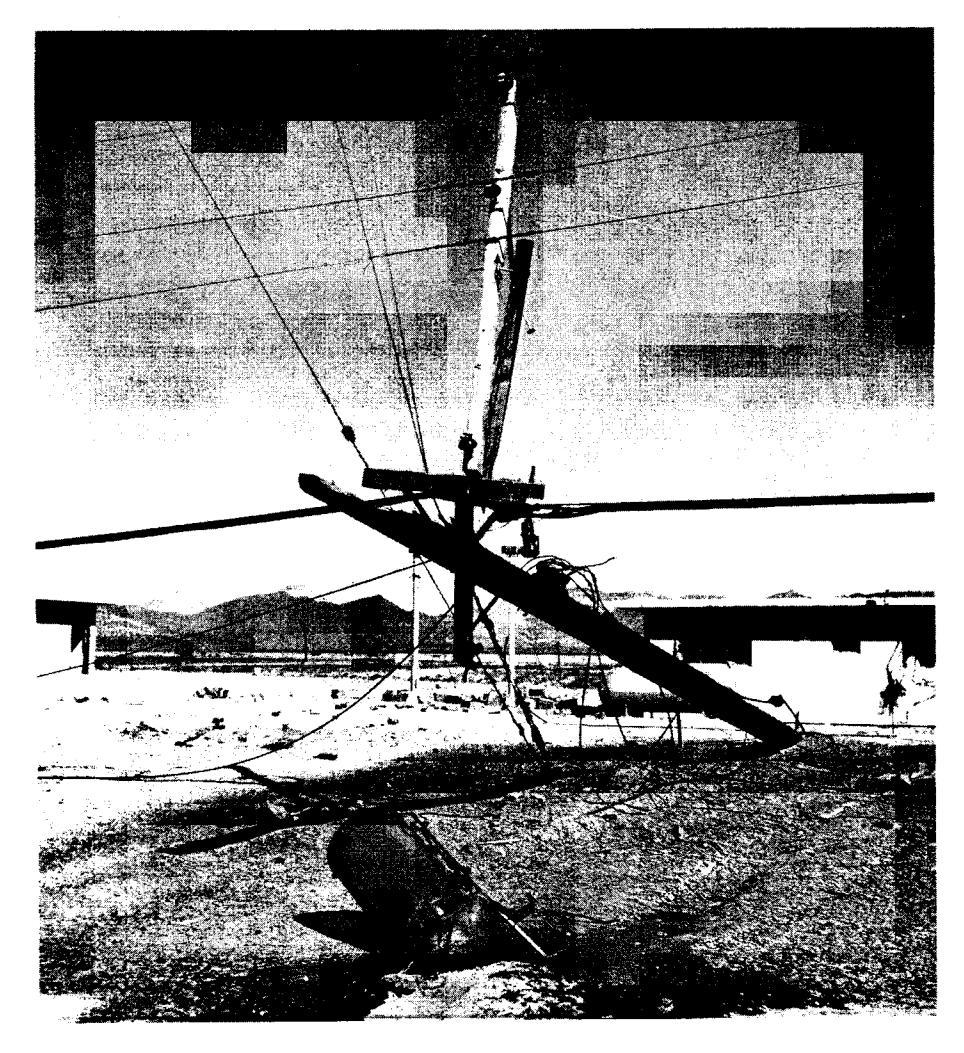
Figure 5.105. Transformer fallen from collapsed utility pole (5 psi peak overpressure), Nevada Test Site.

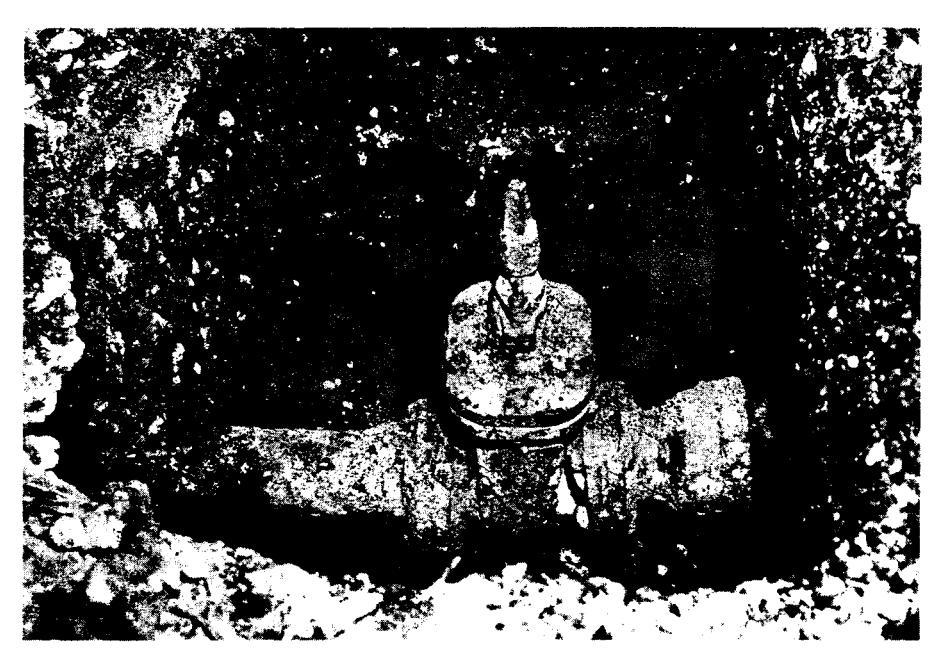
Figure 5.106a. Four-inch gate valve in water main broken by debris from brick wall (0.23 mile from ground zero at Hiroshima).

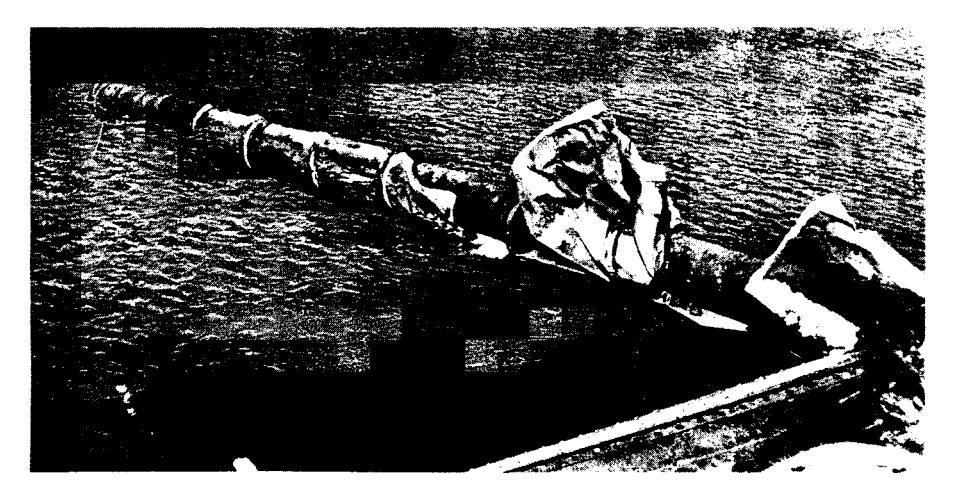
Figure 5.106b. Broken portion of 16-inch water main carried on bridge (0.23 mile from ground zero at Hiroshima).

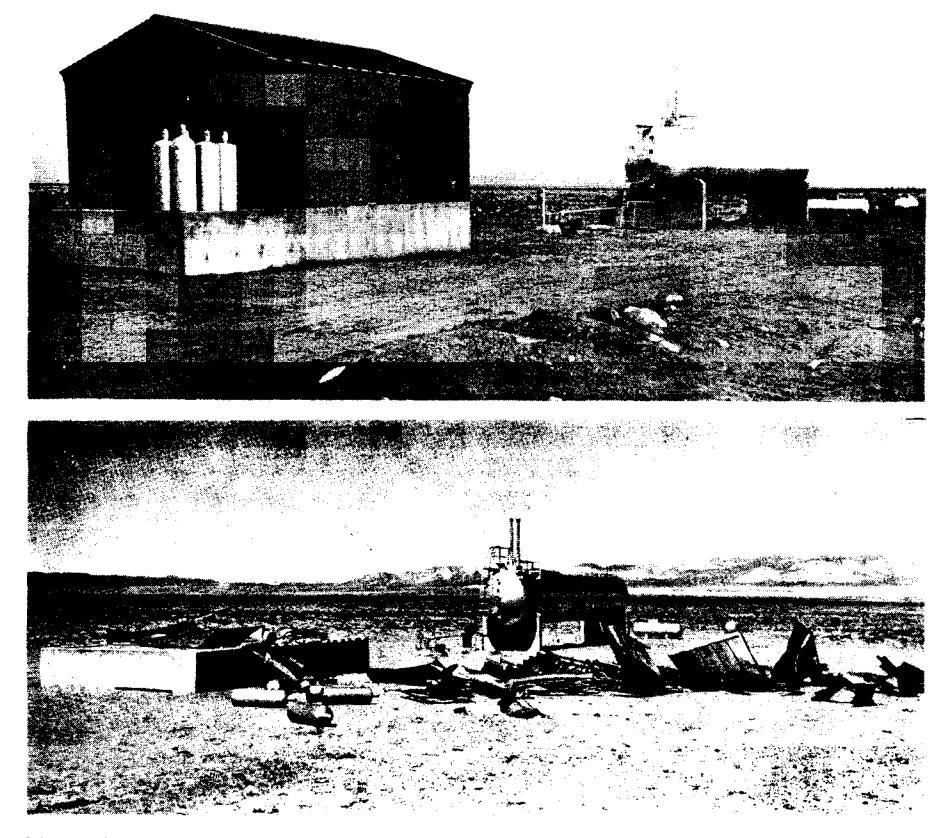
Figure 5.120. Upper photo: LP-gas bulk storage and filling plant before a nuclear explosion. Lower photo: The plant after the explosion (5 psi peak overpressure).

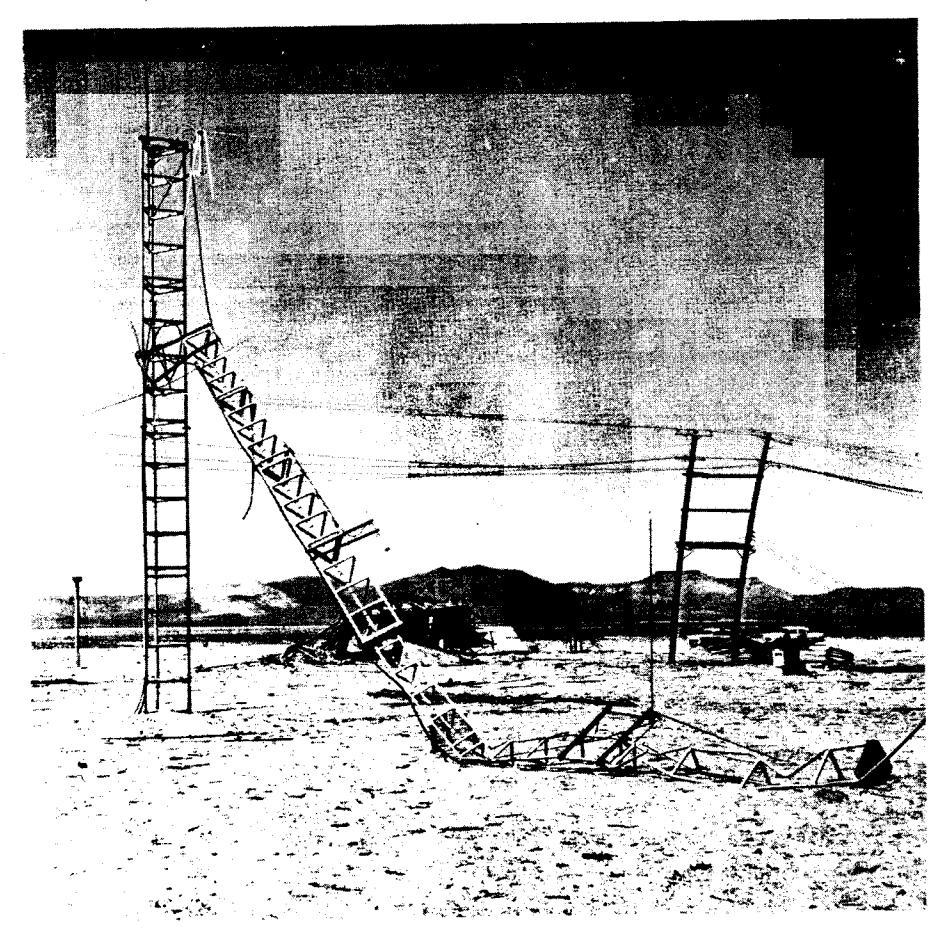
Figure 5.124. Unguyed lightweight 120-foot antenna tower (5 psi peak overpressure, 0.6 psi dynamic pressure from 30-kiloton explosion), Nevada Test Site.

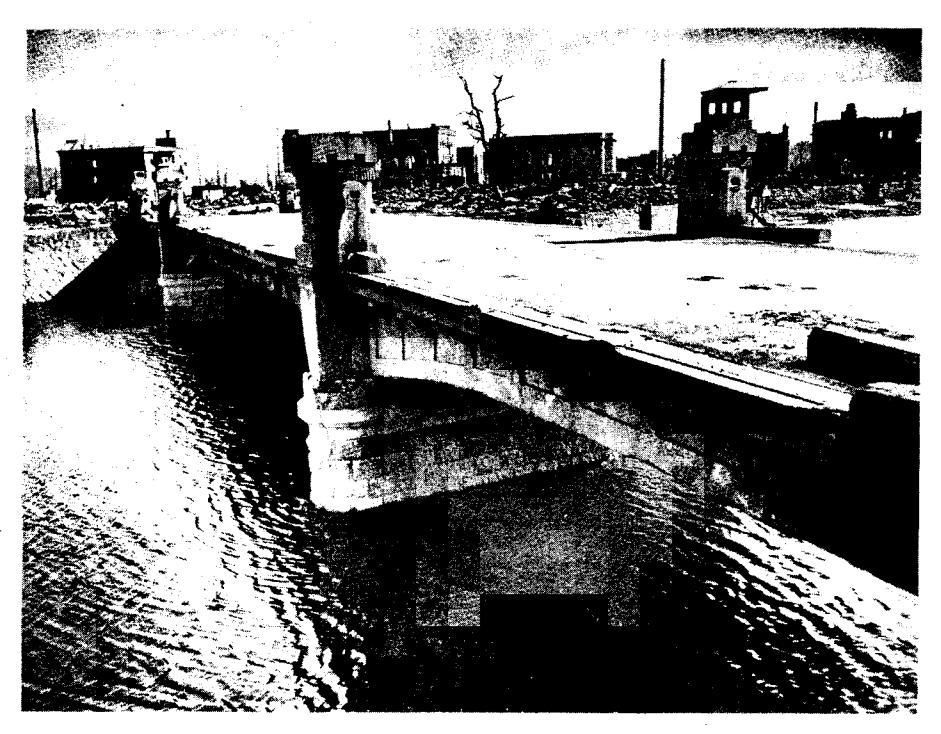
Figure 5.127a. Bridge with deck of reinforced concrete on steel-plate girders; outer girder had concrete facing (270 feet from ground zero at Hiroshima). The railing was blown down but the deck received little damage so that traffic continued.

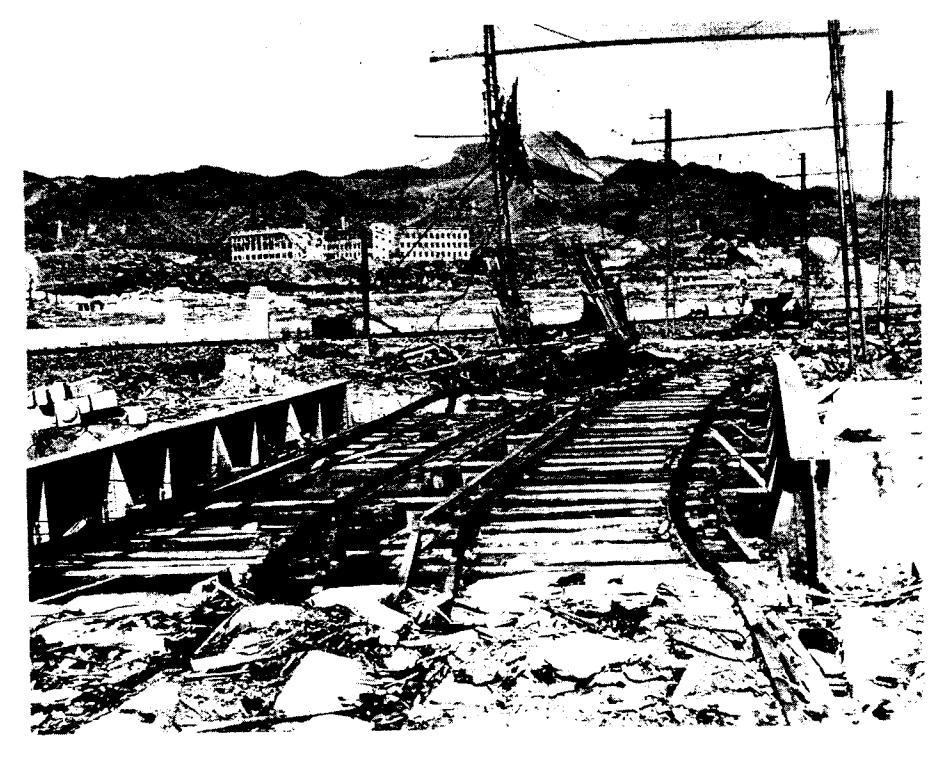
Figure 5.127b. A steel-plate girder, double-track railway bridge (0.16 mile from ground zero at Nagasaki). The plate girders were moved about 3 feet by the blast; the railroad track was bent out of shape and trolley cars were demolished, but the poles were left standing.

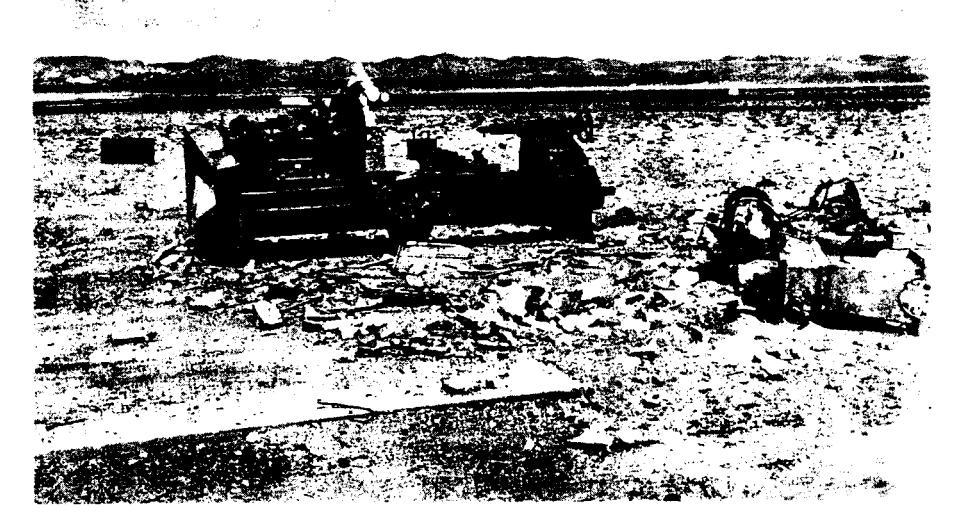
Figure 5.129a. Machine tools after a nuclear explosion (10 psi peak overpressure).

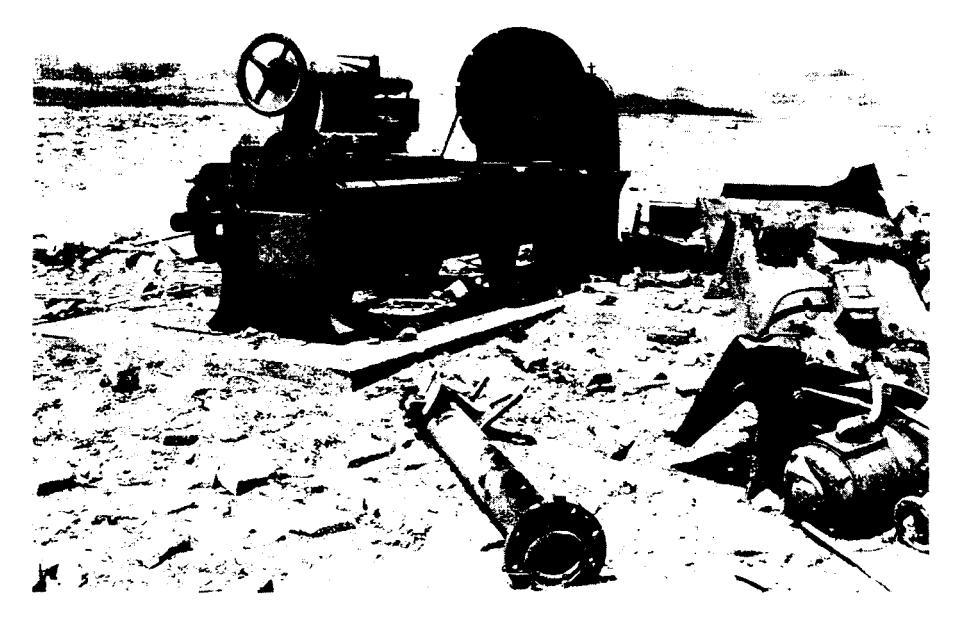
Figure 5.129b. Heavy-duty lathe after a nuclear explosion (10 psi peak overpressure).
