CHAPTER V

STRUCTURAL DAMAGE FROM AIR BLAST

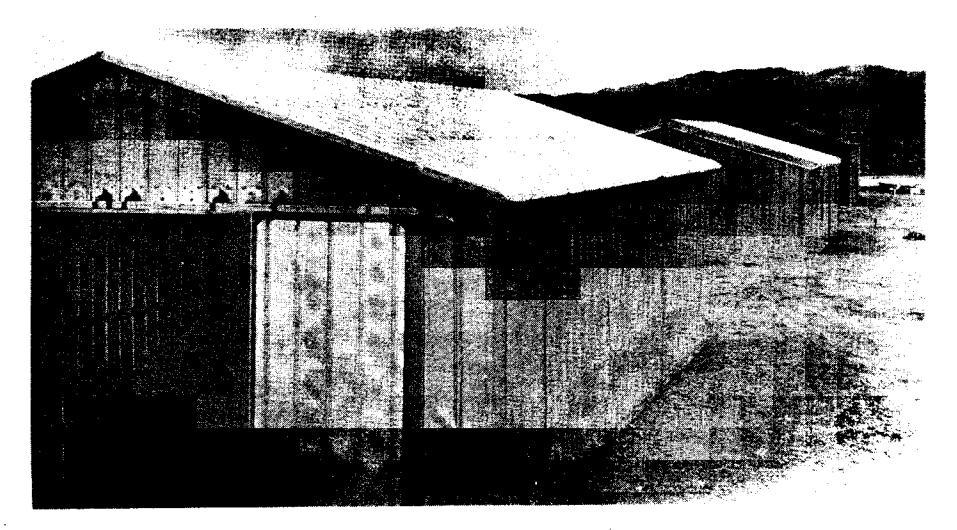
Rigid steel-frame building before a nuclear explosion, Nevada Test Site. Figure 5.37a.

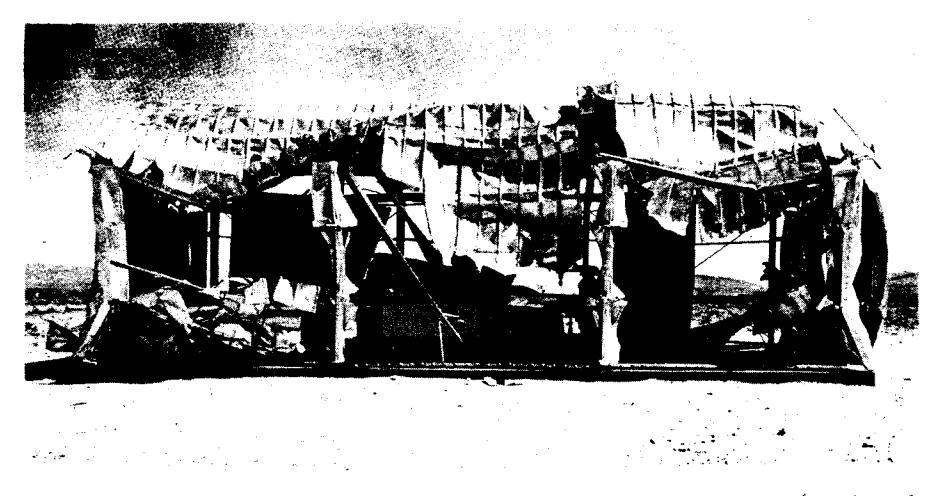
Figure 5.37b. Rigid steel-frame building after a nuclear explosion (3.1 psi peak overpressure).

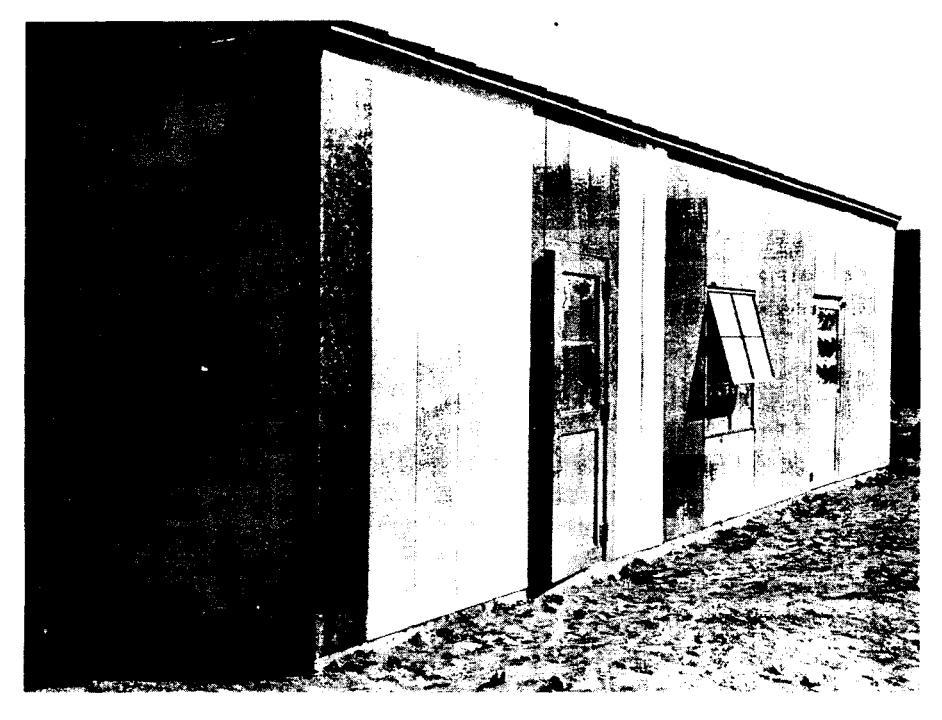
5.40 A frameless structure with self-supporting walls and roof of light, channel-shaped, interlocking, steel panels (16 inches wide) represented the second standard type of industrial building (Fig. 5.40a). The one subjected to 3.1 pounds per square inch peak overpressure (and a dynamic pressure of

Figure 5.40a. Exterior of self-framing steel panel building before a nuclear explosion, Nevada Test Site.

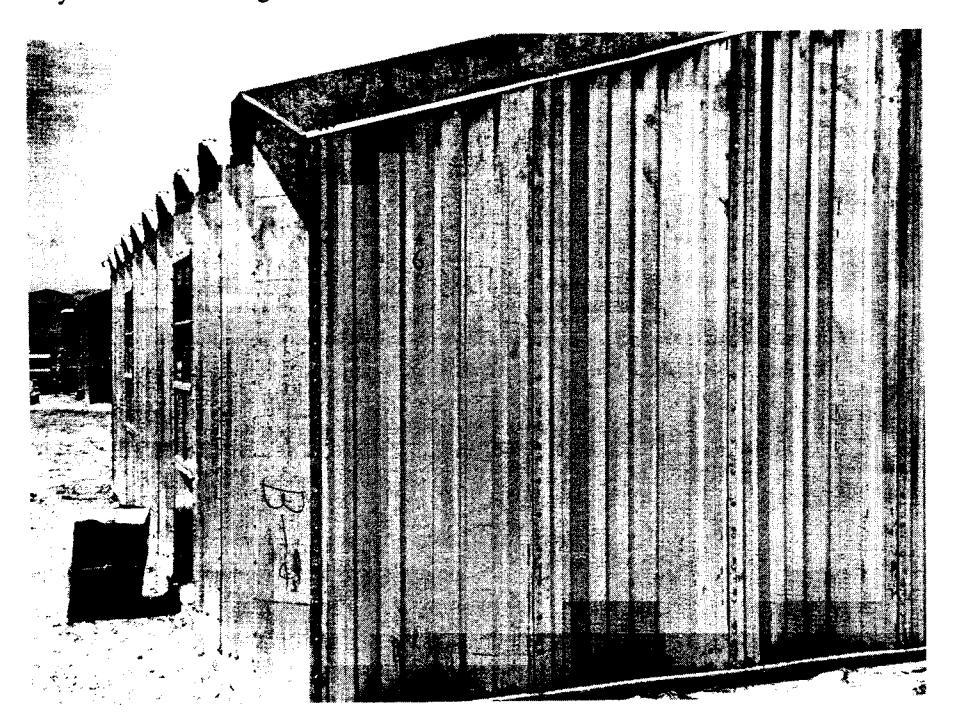
5.43 The third type of industrial building was a completely frameless structure made of strong, deeply-corrugated 43-inch wide panels of 16-gauge steel sheet. The panels were held together with large bolt fasteners at the sides and at the eaves and roof ridge. The wall panels were bolted to the concrete foundation. The entire structure was self-supporting, without frames, girts, or purlins (Fig. 5.43).

Figure 5.43. Self-framing corrugated steel panel building before a nuclear explosion, Nevada Test Site.

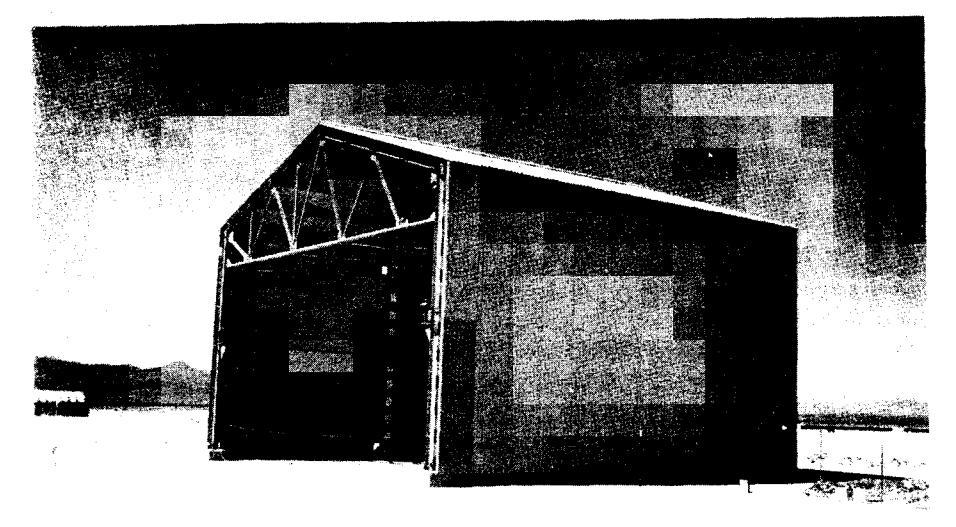
Figure 5.48a. Steel-frame building with siding and roof of frangible material.

tions in the kiloton and megaton ranges. Two representative types of small industrial buildings were chosen for these tests. One had a steel frame covered with siding and roofing of a frangible material and was considered to be a drag-type structure (Fig. 5.48a). The other had the same steel frame and roofing, but it had concrete siding with a window opening of about 30 percent of the wall area; this was regarded as a semidrag structure (Fig. 5.48b).

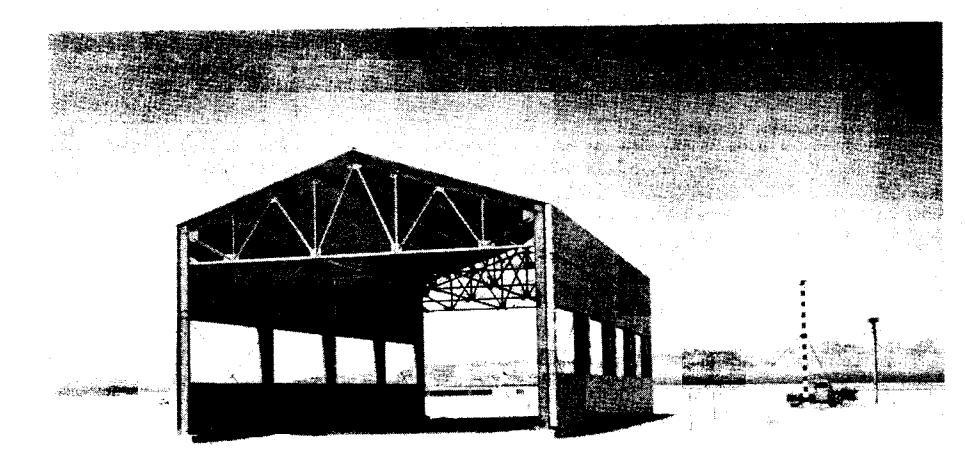
Figure 5.48b. Steel-frame building with concrete siding and window openings of 30 percent of the wall area.

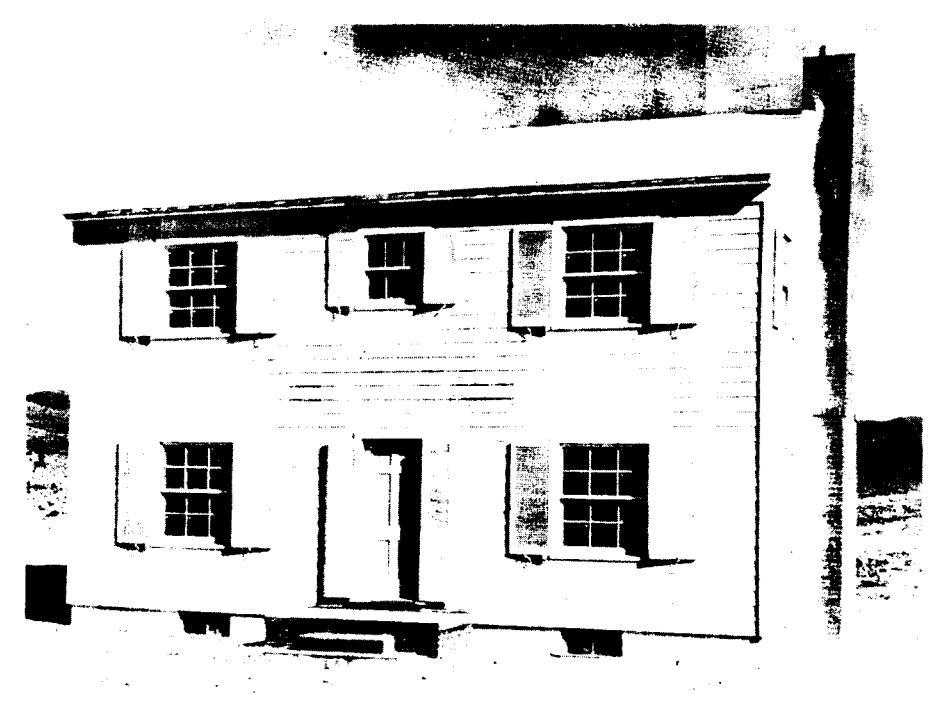
5.55 In the 1953 test, two essentially identical houses, of a type common in the United States, were placed at different locations. They were of typical wood-frame construction, with two stories, basement, and brick chimney (Fig. 5.55). The interiors were plastered but not painted. Since the tests were intended for studying the effects of blast, precautions were taken to prevent the houses from burning. The exteriors were consequently painted white (except for the shutters), to reflect the thermal radiation. For the same purpose, the windows facing the explosion were equipped with metal venetian blinds having an aluminum finish. In addition, the houses were roofed with light-gray shingles; these were of asbestos cement for the house nearer to the explosion where the chances of fire were greater, whereas asphalt shingles were used for the other house. There were no utilities of any kind.

Figure 5.55. Wood-frame house before a nuclear explosion, Nevada Test Site.

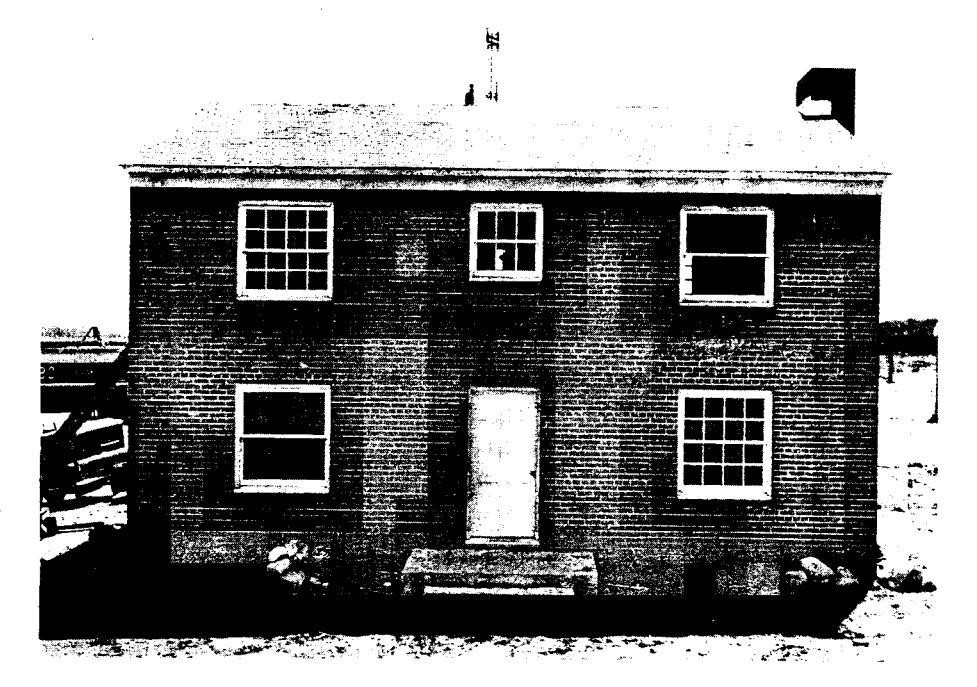
5.66 For comparison with the tests on the two-story, wood-frame structures made in Nevada in 1953, two brickwall-bearing houses of conventional construction, similar in size and layout, were exposed to 5 and 1.7 pounds per square inch peak overpressure, respectively, in the 1955 tests (Fig. 5.66). The exterior walls were of brick veneer and cinder block and the foundation walls of cinder block; the floors, partitions, and roof were wood-framed.

Figure 5.66. Unreinforced brick house before a nuclear explosion, Nevada Test Site.

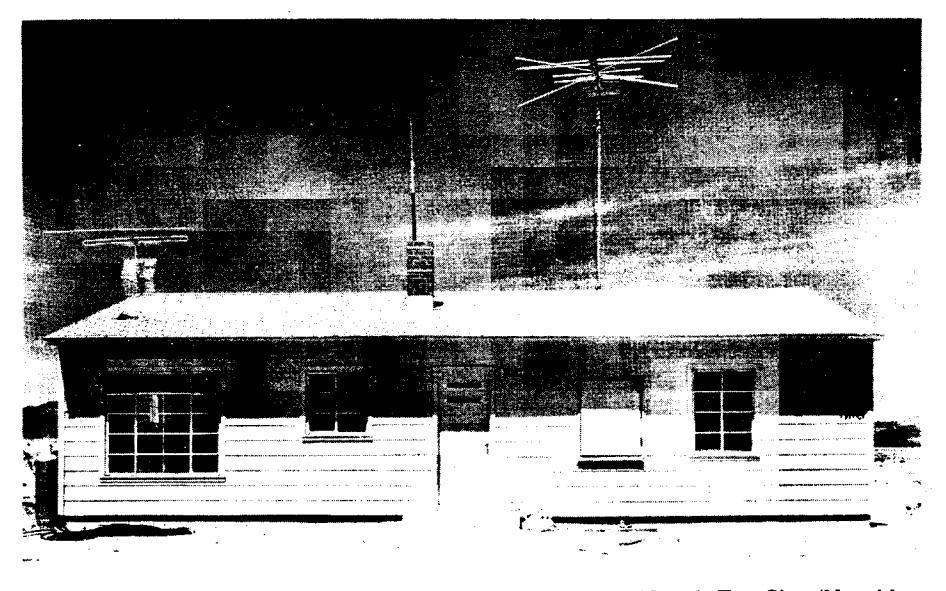
5.69 A pair of the so-called "rambler" type, single-story, wood-frame houses were erected at the Nevada Test Site on concrete slabs poured in place at grade. They were of conventional design except that each contained a shelter, above ground, consisting of the bathroom walls, floor, and ceiling of reinforced concrete with blast door and shutter (Fig. 5.69).

Figure 5.69. Rambler-type house before a nuclear explosion, Nevada Test Site. (Note blast door over bathroom window at right.)

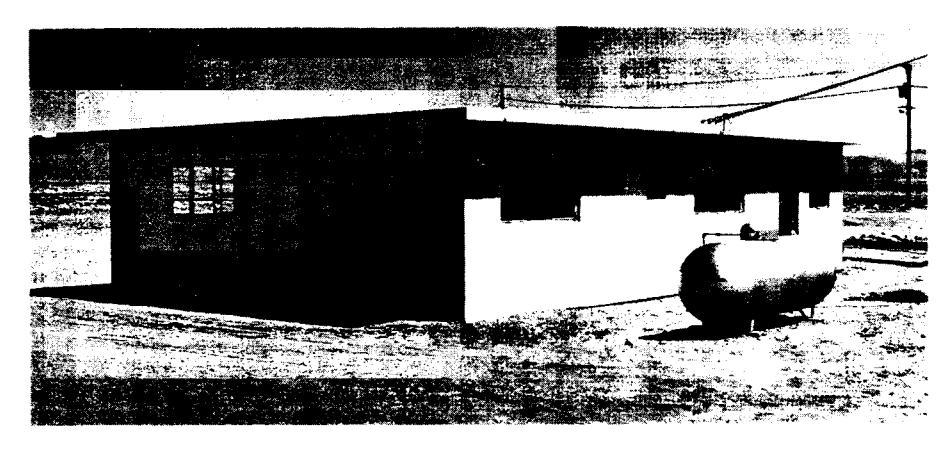
Figure 5.72. Reinforced precast concrete house before a nuclear explosion, Nevada Test Site.

inserts in the wall panels. The overall design was such as to comply with the California code for earthquake-resistant construction (Fig. 5.72).

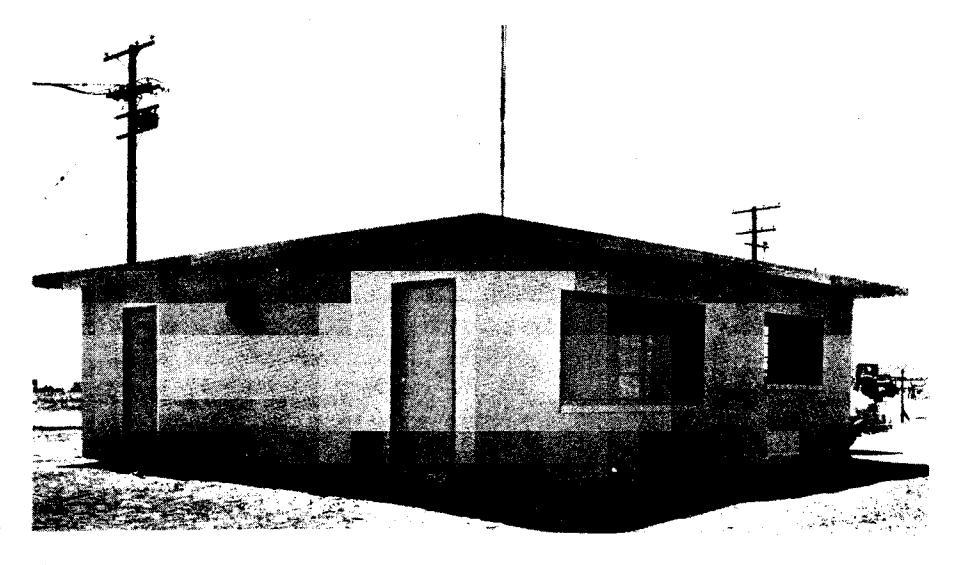
5.76 The last type of house subjected to test in 1955 was also of earthquake-resistant design. The floor was a concrete slab, poured in place at grade. The walls and partitions were built of lightweight (expanded shale aggregate) 8-inch masonry blocks, reinforced with vertical steel rods anchored into the floor slab. The walls were also reinforced with horizontal steel rods at two levels, and openings were spanned by reinforced lintel courses. The roof was made of precast, lightweight concrete slabs, similar to those used in the precast concrete houses described above (Fig. 5.76).

Figure 5.76. Reinforced masonry-block house before a nuclear explosion, Nevada Test Site.

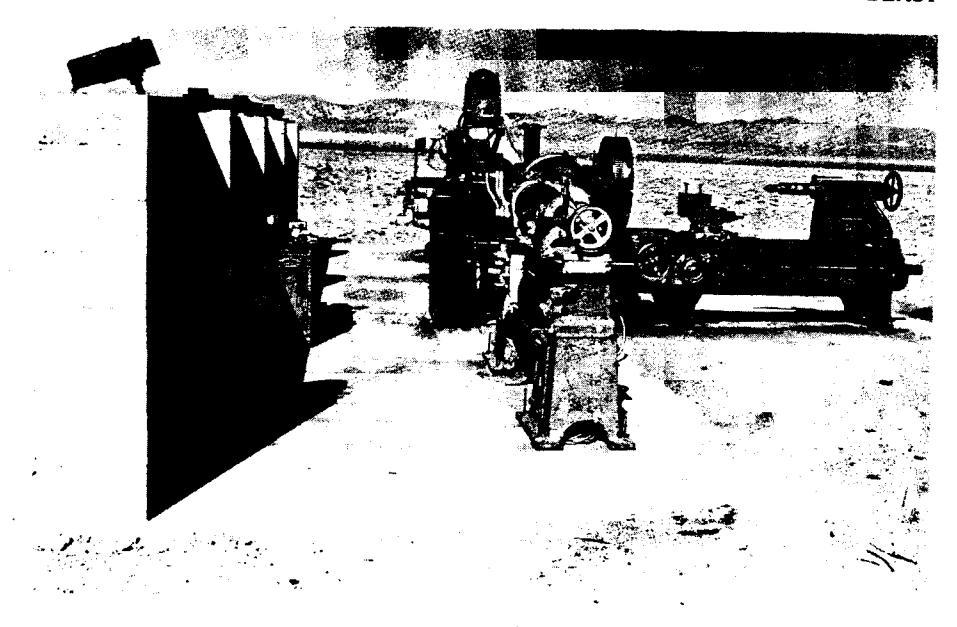
concrete slab in such a manner as to duplicate good industrial practice. Two engine lathes (weighing approximately 7,000 and 12,000 pounds, respectively), and two horizontal milling machines (7,000 and 10,000 pounds, respectively) were exposed to a peak overpressure of 10 pounds per square inch. A concrete-block wall, 8 inches thick and 64 inches high, was constructed immediately in front of the machines, i.e., between the machines and ground zero (Fig. 5.128). The purpose of this wall was to simulate the exterior wall of the average industrial plant and to provide debris and missiles.

Figure 5.128. Machine tools behind masonry wall before a nuclear explosion, Nevada Test Site.

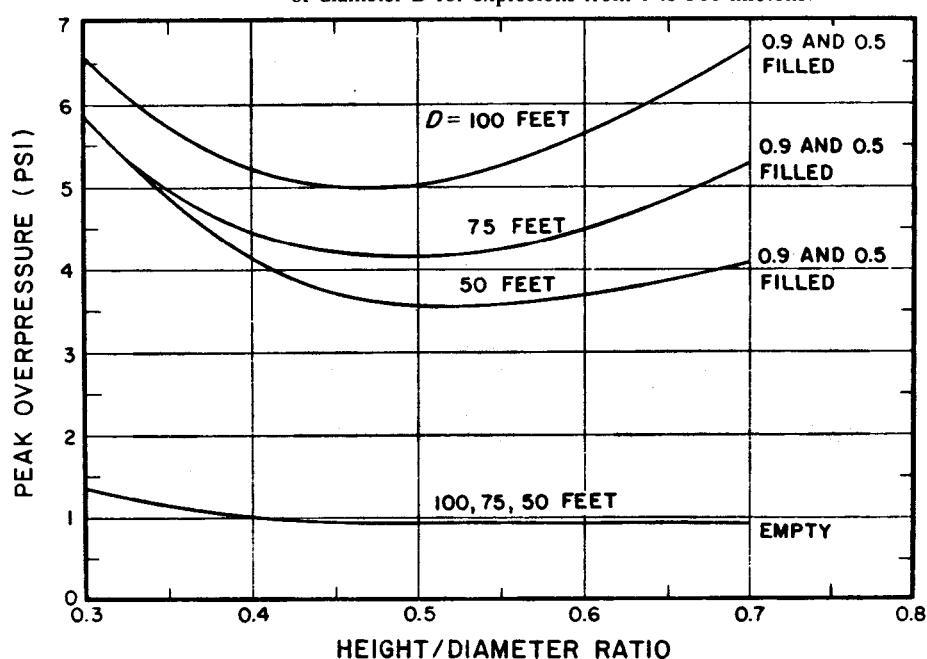
5.155 The chief cause of failure of POL (petroleum, oil, lubricant) storage tanks exposed to the blast wave appears to be the lifting of the tank from its foundation. This results in plastic deformation and yielding of the joint between the side and bottom so that leakage can occur. Severe damage is regarded as that damage which is associated with loss of the contents of the tank by leakage. Furthermore, the leakage can lead to secondary effects, such as the development of fires. If failure by lifting does not occur, it is expected that there will be little, if any, loss of liquid from the tank as a consequence of sloshing. There is apparently no clearcut overall structural collapse which initially limits the usefulness of the tank. Peak overpressures required for severe damage to POL tanks of diameter Dmay be obtained from Figs. 5.155a and b. Figure 5.155a is applicable to nuclear explosions with energy yields from 1 to 500 kilotons and Fig. 5.155b to yields over 500 kilotons. For yields less than 1 kiloton, the peak overpressure for severe damage may be taken to be 1 pound per square inch.

Figure 5.155b. Peak overpressures for severe blast damage to floating- or conical-roof tanks of diameter D from explosions of 500 kilotons or more. deformation that the earth provides to flexible structures by the buttressing action of the soil.
